Transport and Main Roads

Independent Audit into the reliability of Queensland Rail's south-east Queensland network

Final report

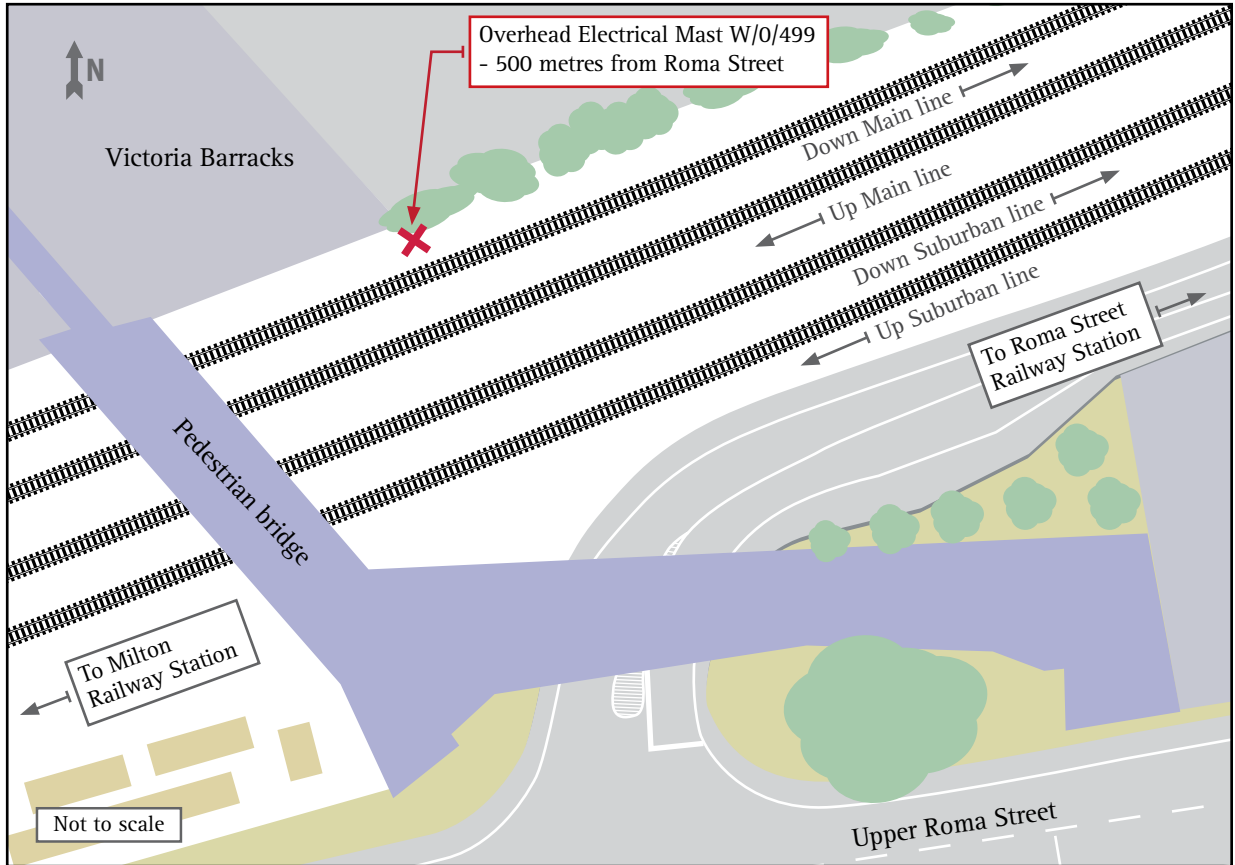
At approximately 0425 hours, a contact wire secured by a wedge clamp located above the Down Main Line approximately 500 metres west of Roma Street railway station on the Western Line corridor fractured, causing a dewirement.

Figure 5 - Dewirement location near Roma Street.

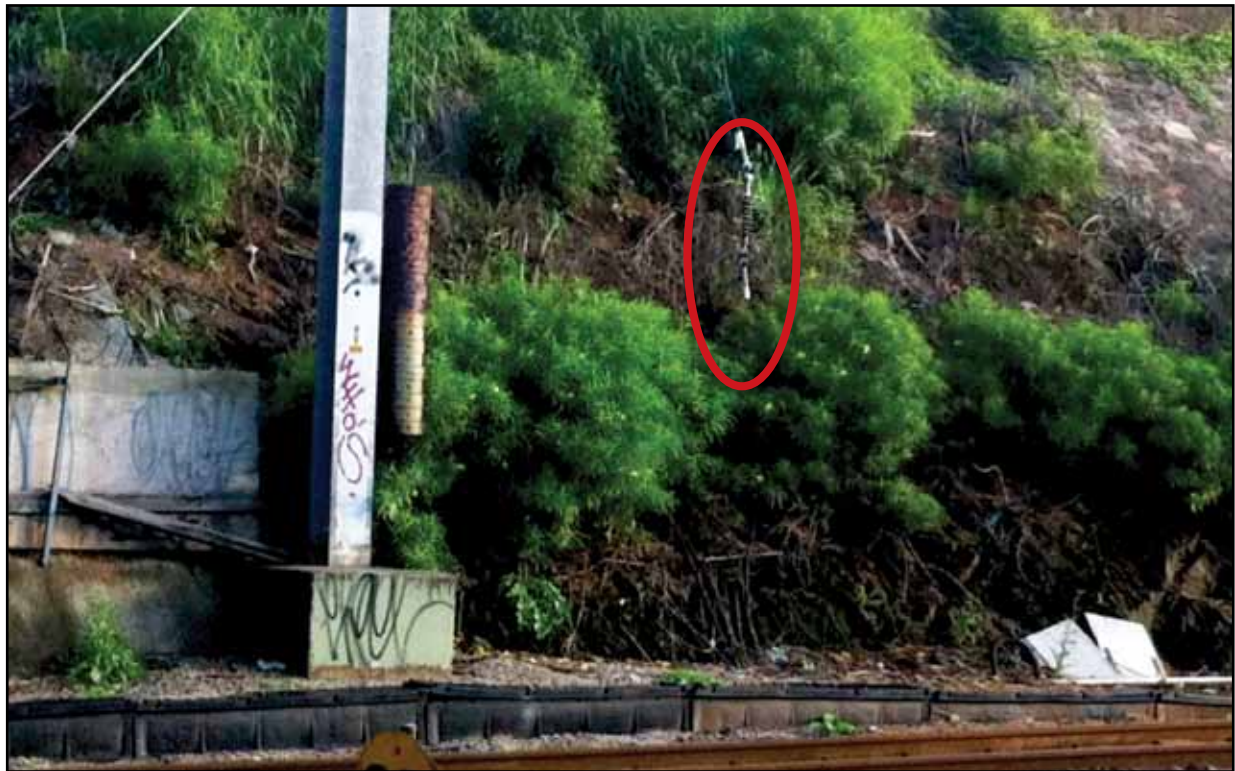
The fractured contact wire was secured by a wedge clamp prior to the incident. This wedge clamp was installed approximately five metres above rail level in the vicinity of the Down Main Line near OHLE mast number W/o/499 (refer Figure 6).

Figure 6 - Dislodged OHLE.

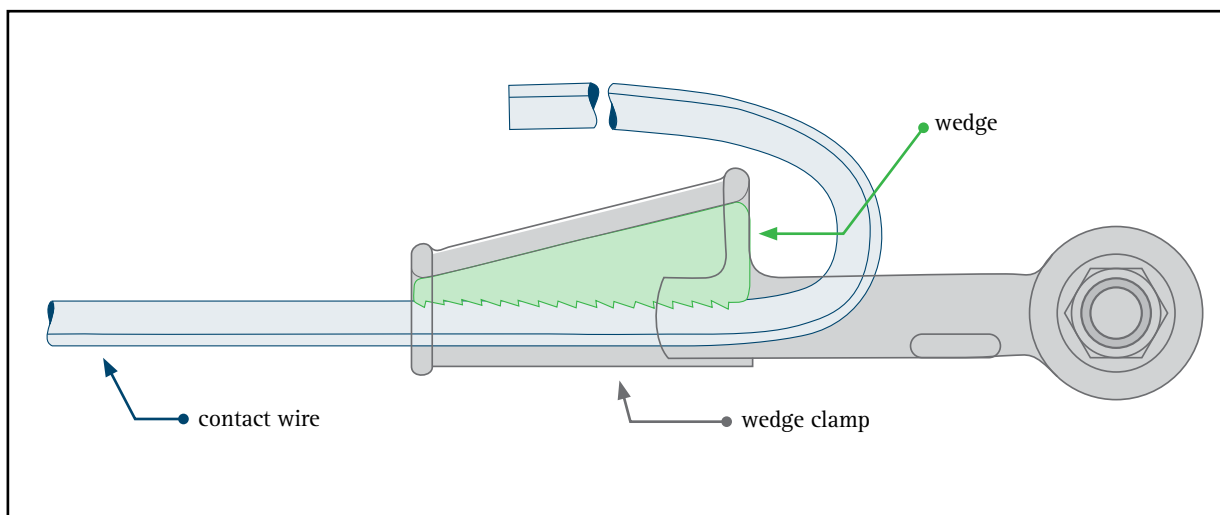
Following the dewirement, the wedge clamp was found to be in good condition; however, the contact wire had not been installed in accordance with the approved construction drawing (Figure 8).

Figure 9 - Incorrect wedge clamp assembly.

It is understood that all other wedge clamps of this type across the network are installed with their contact wire end looped (Figures 9 and 10).

4. recommended (following the technical investigation) that instructions be issued to overhead depots that it is approved for wedge clamps to be used on contact wire terminations, however they must be installed precisely as per the construction drawings and the practice of the looping of the contact wire must cease

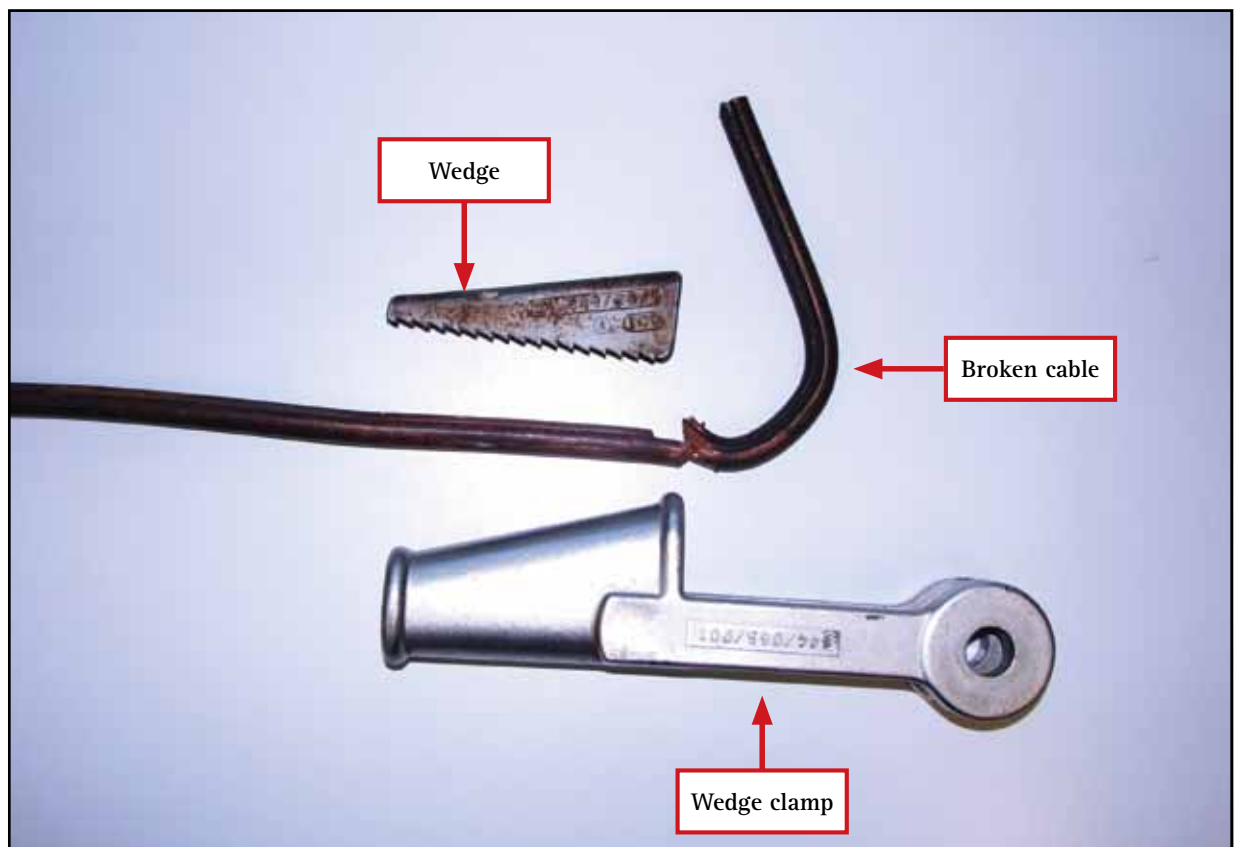
Following the incident, an examination of the incorrectly installed wedge clamp revealed that the installation of the wedge did not provide sufficient grip on the contact wire. This was evidenced through minimal visible marks on the contact wire from the wedge teeth, suggesting wire tension was carried by the loop of the contact wire rather than the wedge. This resulted in a gradual weakening of the contact wire over a small contact area of the loop eventually fracturing the contact wire.

Figure 12 – Incorrectly installed wedge clamp.

The dewirement was caused by the insufficient gripping of the contact wire due to incorrect installation of the wedge clamp.

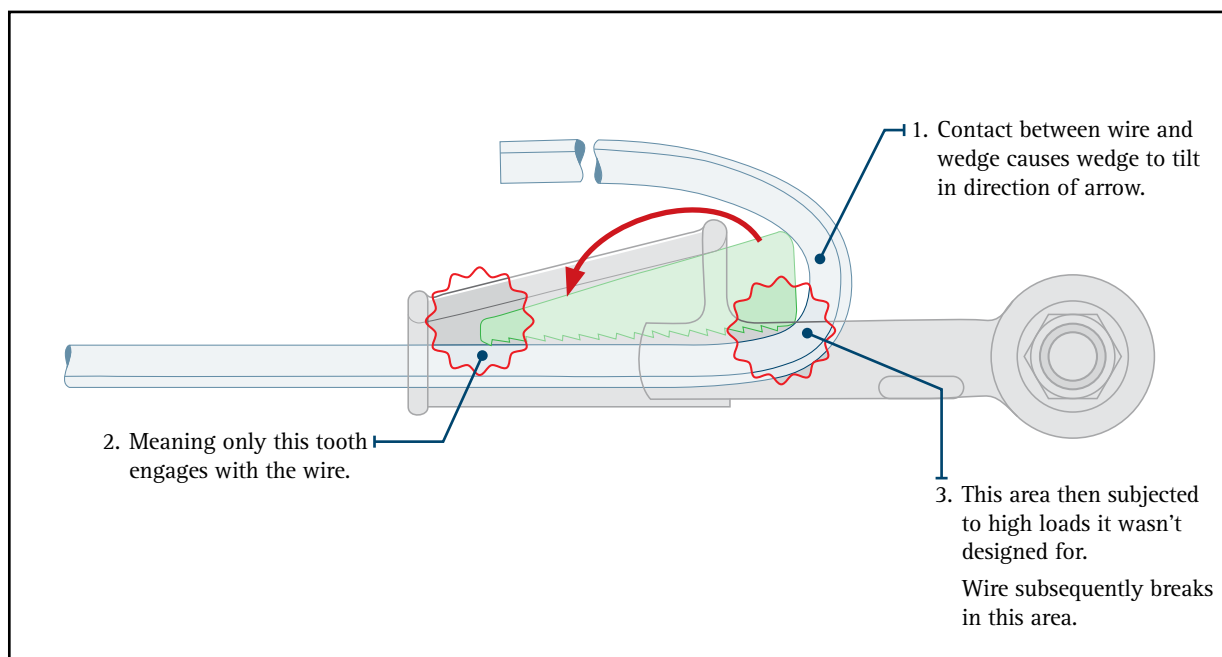
Appropriate installation of the wedge clamp requires that the contact wire has only a slight bend beyond the end of the wedge clamp (Figure 8). At the time of installation, the installation practice on this type of wedge clamp was to bend (loop) the contact wire around the back of the wedge clamp (Figure 9 and 10). Engineering tests, following the incident, confirmed that it is immaterial whether the contact wire is looped or not as long as the wedge has been installed properly to provide sufficient grip on the contact wire. In this instance it appears that the act of bending the contact wire prior to placing the clamp under tension has prevented it from properly engaging the wedge. The most likely failure mechanism is illustrated in Figure 13.

Figure 13 – Failure mechanism.

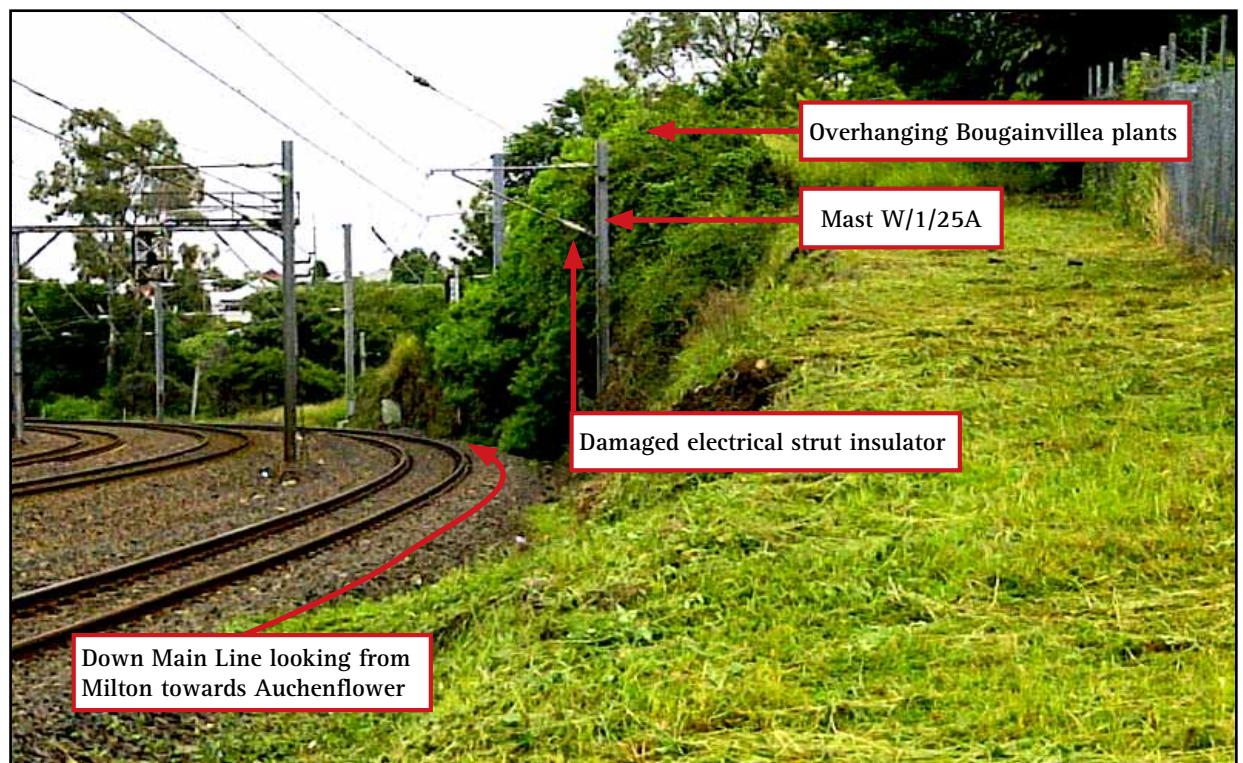
The Down Main Line at this location is adjacent to a steep cutting on the northern side of the rail corridor which at the time of the incident was covered with vegetation in close proximity to the OHLE trackside mast W/1/25A.

Figure 17 – Photograph of the incident site looking towards Auchenflower from Milton on the Down Main Line Western Corridor (photo taken 14 March 2012).

Following the incident OHLE staff located a severe burn mark on the ceramic strut insulator and on a Bougainvillea cane. The face of the cutting had overgrown vegetation including several Bougainvillea plants. Evidence suggests that some Bougainvillea canes were over three metres in length.

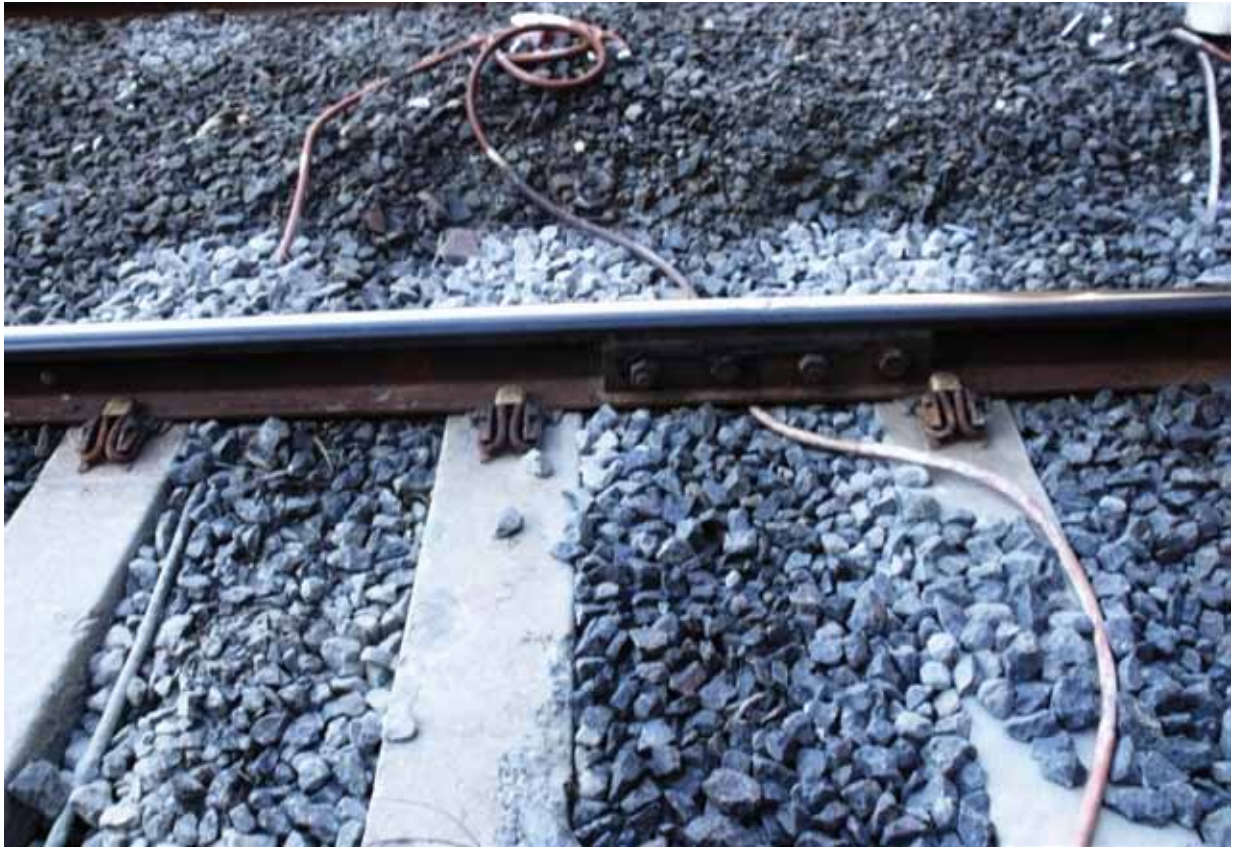
Figure B1 – Pumping sleepers (down main line between Fortitude Valley and Bowen Hills).

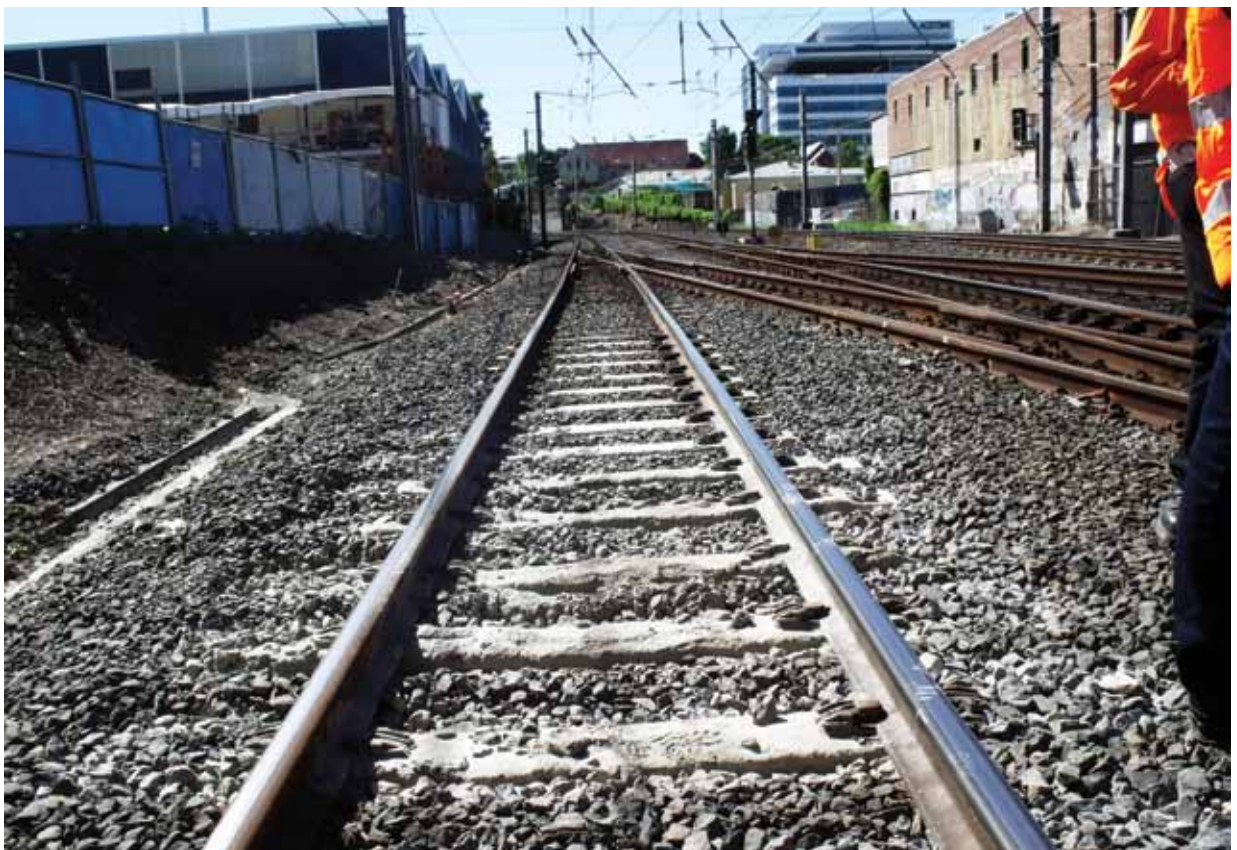
Figure B2 – Pumping sleepers and mud hole (down main line between Fortitude Valley and Bowen Hills).

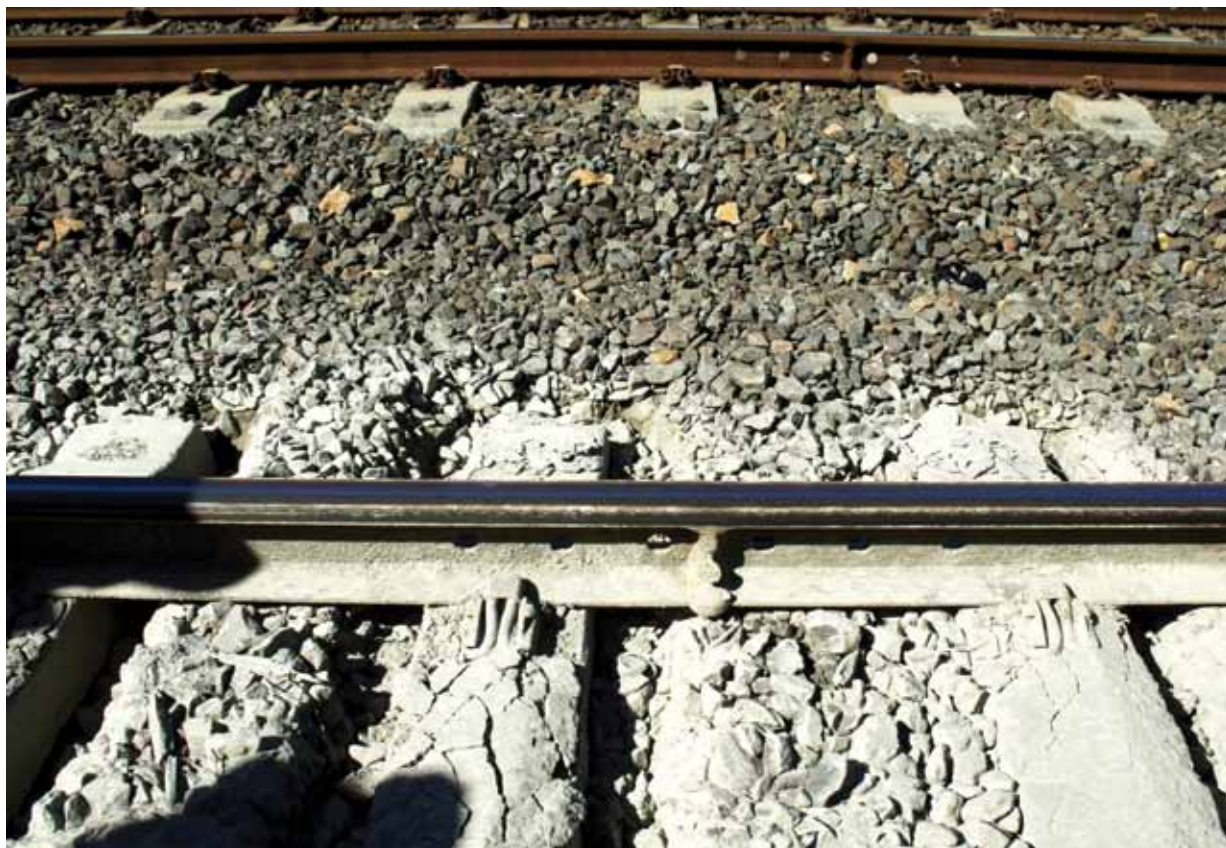
Figure B3 – Pumping sleepers and mud hole (down main line between Milton and Auchenflower).

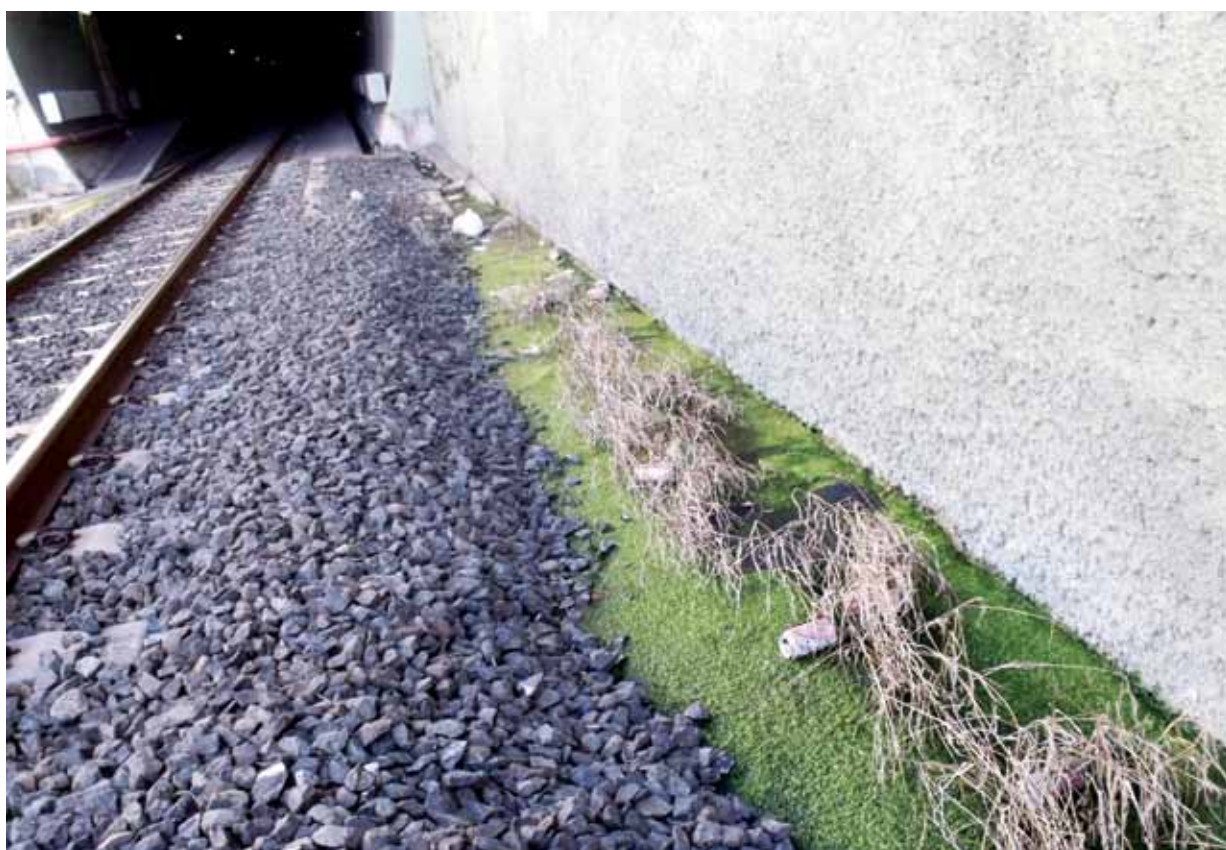
Figure B4 – Blocked drain at northern entrance to number 1 tunnel Fortitude Valley.

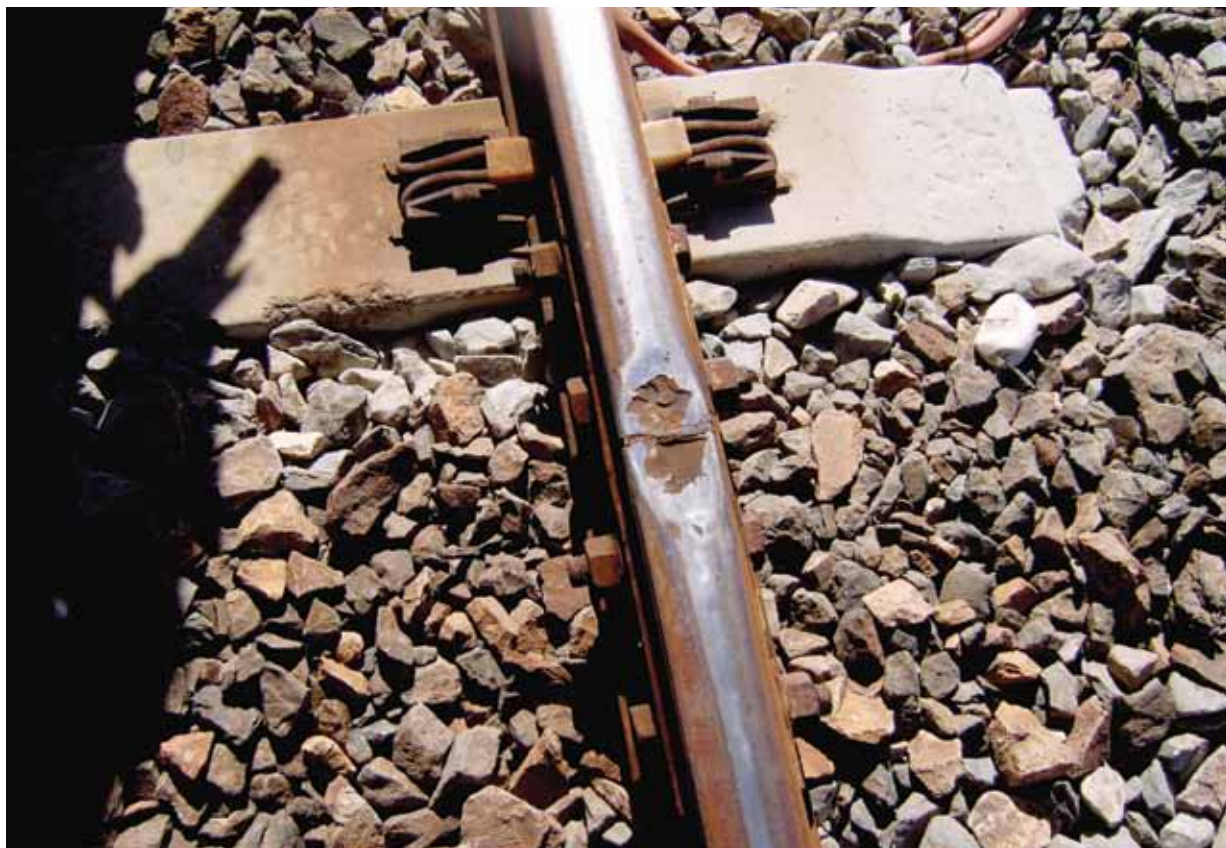
Figure B5 – Rail head damage on an insulated joint (down main line between Corinda and Sherwood). Photograph was taken on 15 May 2012 and the damage was repaired on 20 May 2012.

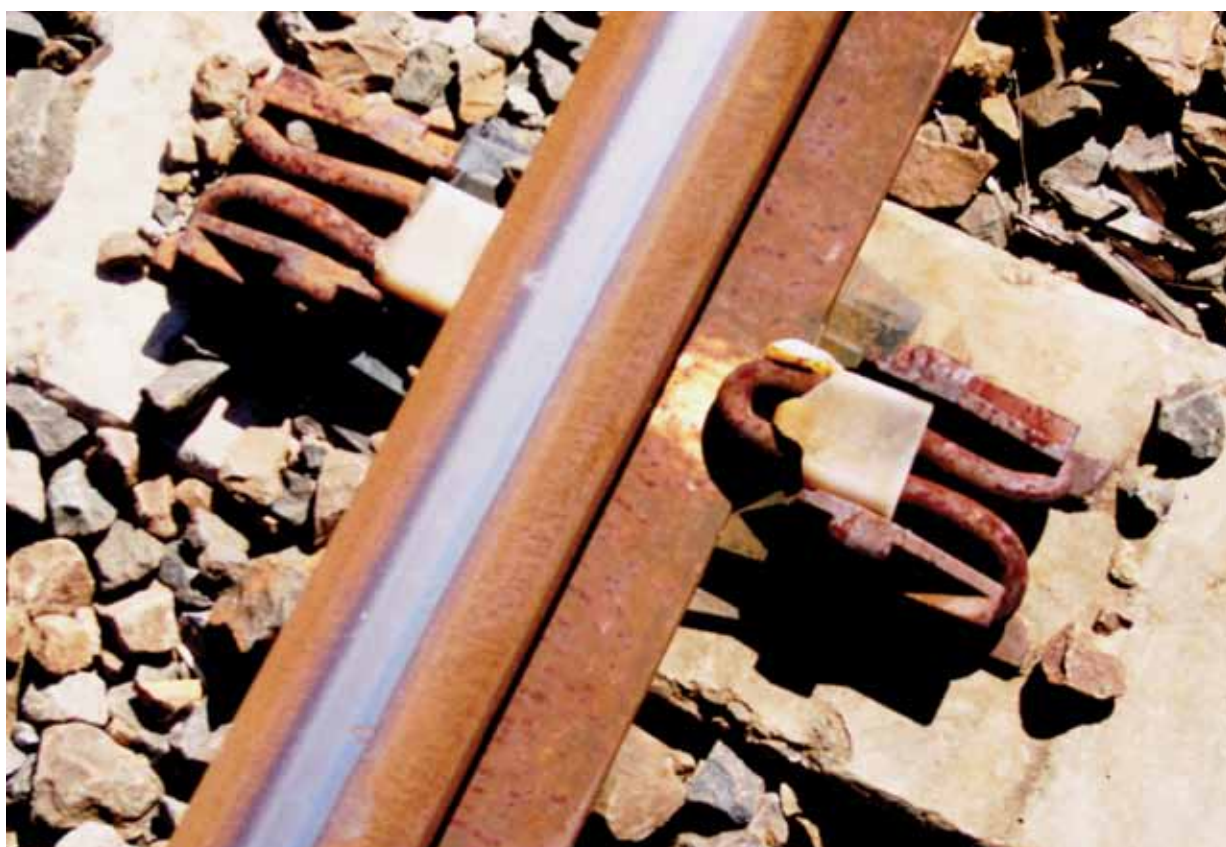
Figure B6 – Damaged rail fastening insulator (down main line between Corinda to Sherwood).
