Evaluation of Linemarking Modifications on the Ted Smout Bridge

Prepared for Department of Transport and Main Roads

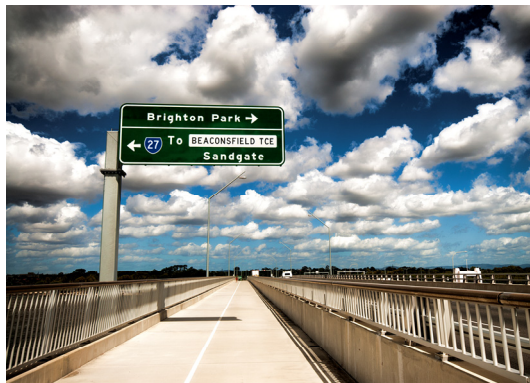
The Ted Smout Bridge extends over 2.8 km between Brighton and Redcliffe. The bridge opened in 2010 and provides for three southbound traffic lanes and a bi-directional bikeway and footpath on the eastern side of the bridge. When initially constructed the 4.5 m width of the path was divided into a 2.5 m bikeway nearest the roadway (but separated by a concrete barrier and fence) and 2.0 m footpath segregated from the bikeway by a solid white edgeline (Figure 1.1a).

(a) Original configuration

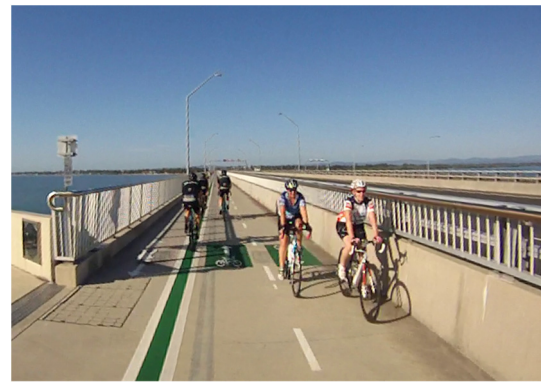
Following a number of near-miss events and anecdotal reports of collisions between bicycle riders, in 2016 two bicycle riders collided in a head-on collision which resulted in one rider incurring serious injuries. In that incident two groups of riders were approaching one another, and the rider who incurred the serious injuries was towards the rear of one of the groups. In response to this collision, and to the reports of near-miss events, TMR redesigned the path with a 2.9 m bikeway, 0.4 m edge strip with solid white edge lines and green infill and a 1.2 m footpath (Figure 1.1b). The modal segregation was reinforced by the use of signs and pavement symbols (with coloured background to enhance contrast). Directional segregation of bicycle riders was encouraged through the use of a dashed centreline and directional arrows above the pavement bicycle symbols.

(b) Modified configuration

- The modified linemarking should to be retained and maintained in its current condition (with the caveat noted below) unless further incidents or information warrant modification.
- When maintenance and reapplication of the green fill treatment is warranted it is suggested an alternative colour not explicitly associated with bicycle riders may be more appropriate.
- Future major works at other locations, including bridges, should carefully consider the likely user demand and profile and consider an appropriate path width accordingly. Our view is that the 4.5 m width allocated on Ted Smout Bridge is inadequate for the safe operation of the path given the user demand and mix.

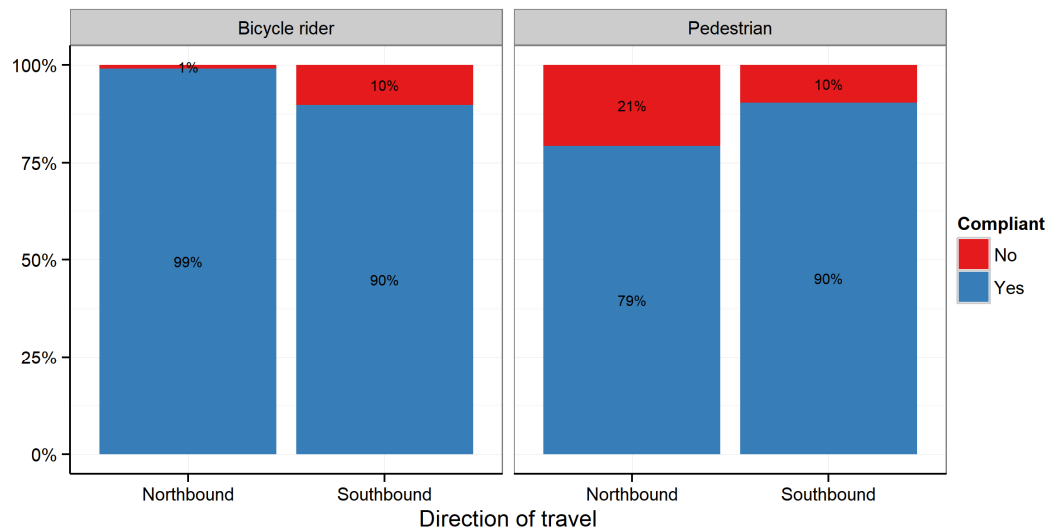
Unsurprisingly, modal compliance was higher when the path user was travelling in the direction that would result in them tending to walk or ride towards the outer edge of the path. In the case of bicycle riders this means better compliance among those heading north (99%) than south (90%) and among pedestrians those heading south (90%) were more likely to comply than those heading north (79%).

■ **Figure 2.2: Modal compliance by direction of travel**

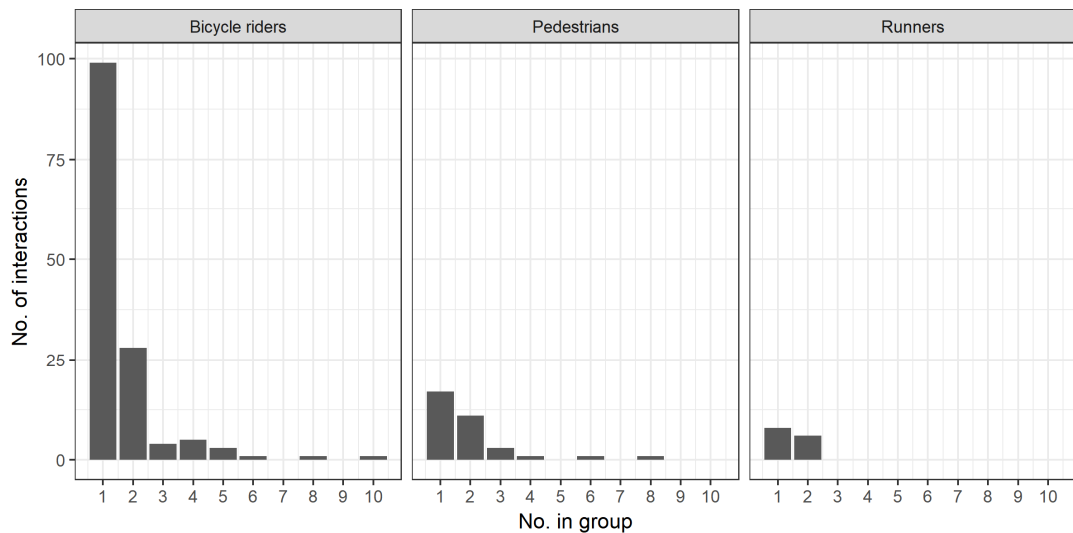
Around 70% of interactions with other bicycle riders involved a single rider, as were half of pedestrian interactions (Figure 2.4). Interactions with groups of three or more bicycle riders constituted only 10% of rider interactions.

■ **Figure 2.4: Interactions by mode and group size**

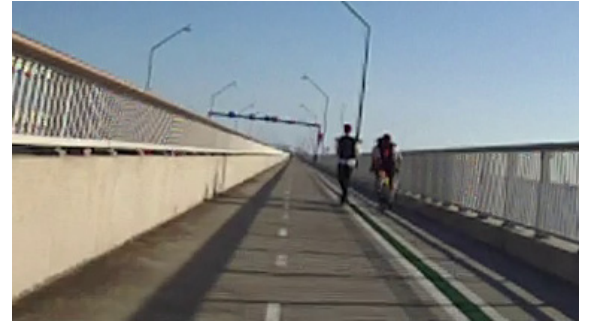
- Two interactions, constituting 1% of all events, were rated as causing surprise or alarm on the part of one or more path users. In one of these a motorised scooter user on the bikeway was drifting left and right and the two bicycle riders who were overtaking had to veer far to their right to overtake (Figure 2.5). In the second incident a bicycle rider drifts left onto the footpath and only notices the oncoming runners at the last minute (Figure 2.6). The rider appears to gesture with their left arm to apologise, while the runners appear to be startled by the interaction.

■ Figure 2.5: Motorised scooter veers over path, forcing overtaking riders far to the right

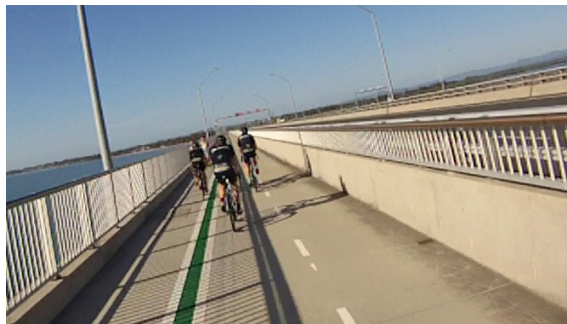
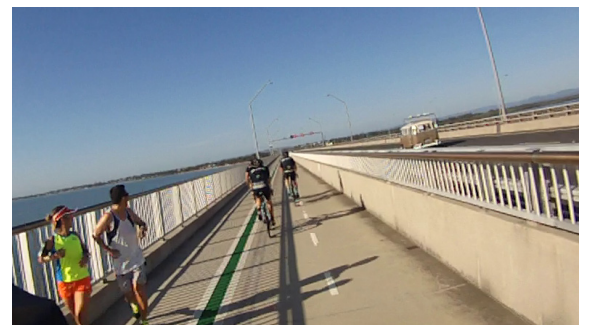
- While the vast majority of interactions were benign, it was the small minority of complex interactions – often involving groups of riders *and* pedestrians – that appear to pose the greatest risk. Moreover, as illustrated by the example of a distracted rider in Figure 2.6, should there be a misunderstanding or lack of attention paid by one or more riders an otherwise benign interaction could rapidly become a serious collision. The narrow width of the path, combined with the typical rider speeds, leave very little margin for error.

(a) Rider drifts left into footpath

(b) Rider notices runners and quickly veers right

(c) Rider puts out hand seemingly to apologise, runner has hand up defensively

(d) Runners look back at riders

■ Figure 2.6: Close collision event between bicycle rider and runners

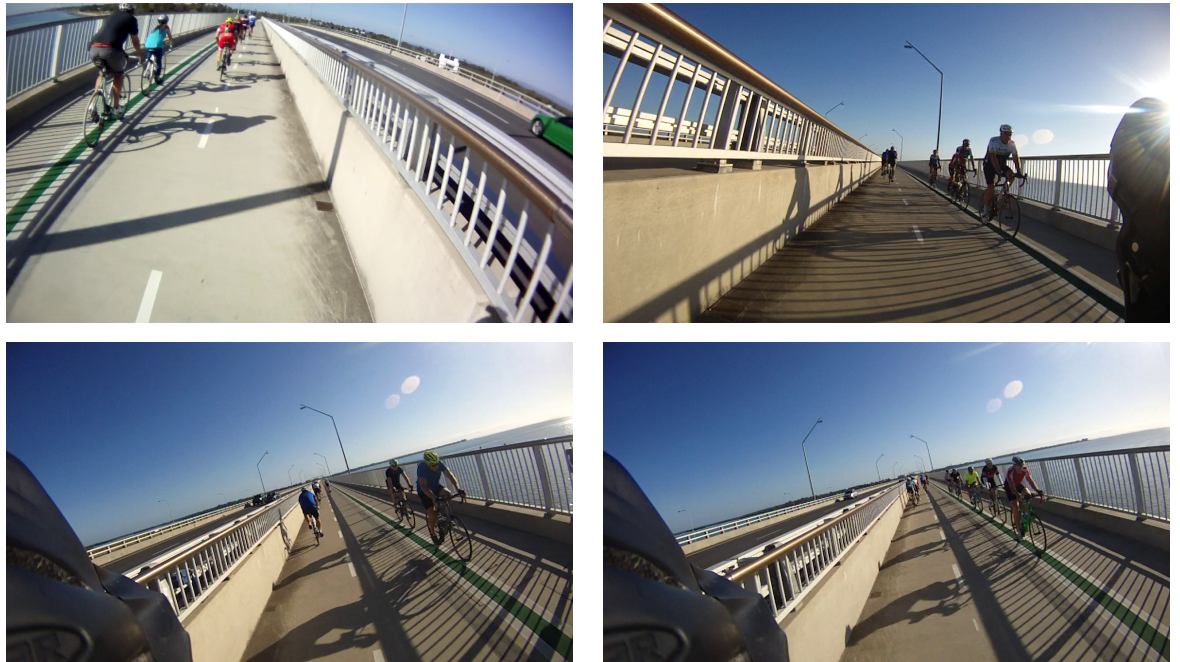
- Most bicycle riders (89%) were observed to travel to the left of the dashed bikeway centreline.
- It was fairly common, particularly during peak cycling periods, to observe southbound bicycle riders tracking along the painted buffer between the bikeway and footpath. This behaviour was usually observed when there were no pedestrians on the footpath.

- It was common to observe bicycle riders travelling south tracking along the edge strip (Figure 2.8). This usually occurred when no pedestrians were present on the footpath and there was one or more oncoming bicycle riders.

■ Figure 2.8: Examples of riders travelling southbound tracking along the edge strip

With regard to the use of the green within the edge strip we note that the green serves the opposite purpose to its common use – namely, that riders should avoid this space. While removing and reapplying this colour is unlikely to be justifiable it is suggested that in future another colour that is not associated with cyclists would be preferable.
