Transport and Main Roads

Independent Audit into the reliability of Queensland Rail's south-east Queensland network

Final report

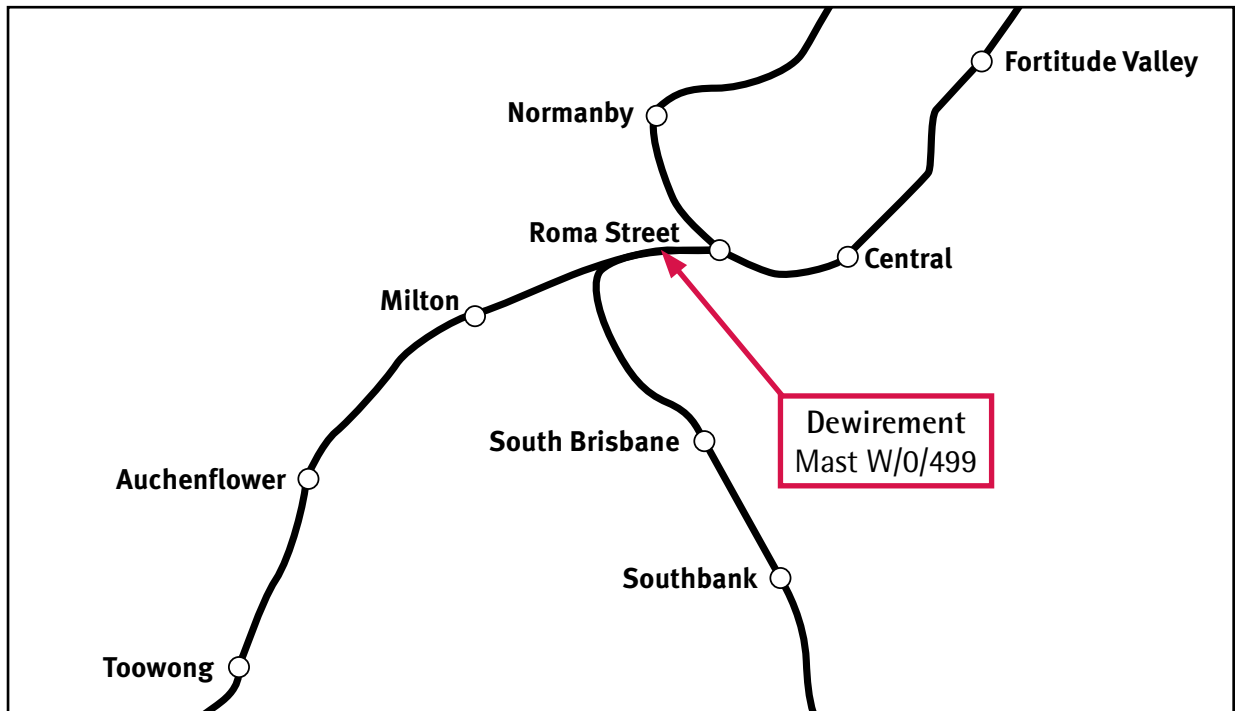
Figure 4 – 28 February 2012 Roma Street incident location.

The location of the dewirement was in close proximity to OHLE mast W/o/499 which is adjacent to the Down Main Line on the western corridor, approximately 500 metres from the Roma Street railway station (refer Figure 4).

At approximately 0425 hours, a contact wire secured by a wedge clamp located above the Down Main Line approximately 500 metres west of Roma Street railway station on the Western Line corridor fractured, causing a dewirement.

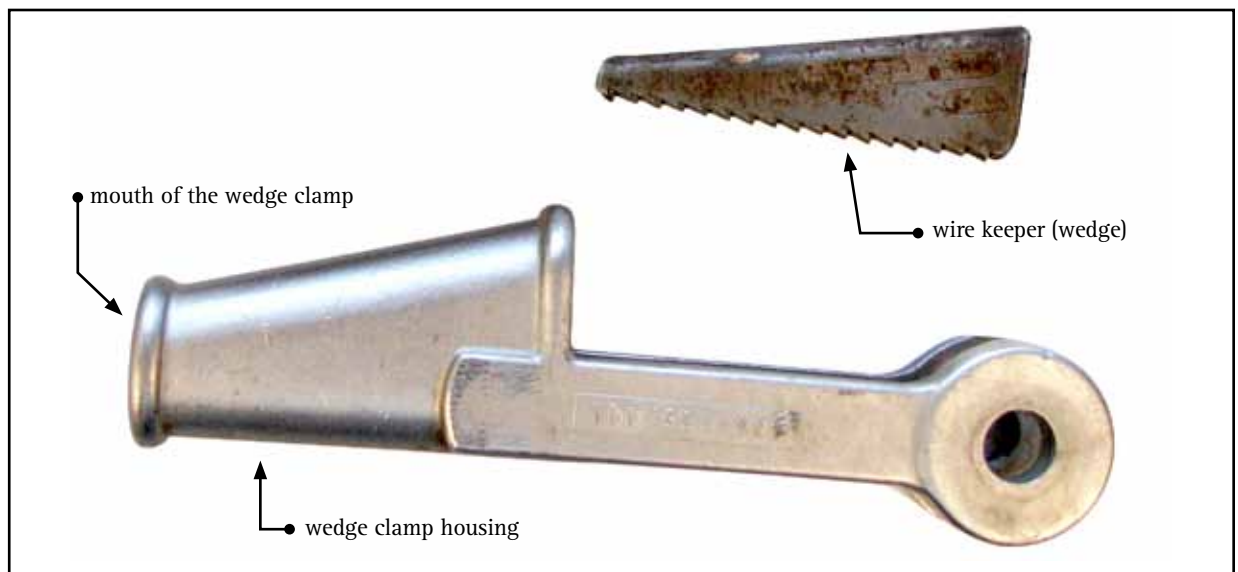
Figure 7 – Wedge clamp assembly.

There are more than 2000 such wedge clamps in operation on the south-east Queensland network. This design of wedge clamp has been installed on the south-east Queensland network from the early 1990s. These wedge clamps are used to connect the end of the contact wire with various components of the OHLE. The wedge clamp is made of two major components, wedge clamp housing and wire keeper (wedge) (Figure 7). The contact wire is passed through the mouth of the wedge clamp housing and is kept secured in the clamp by firm contact of the serrated teeth of the wedge (Figure 8).

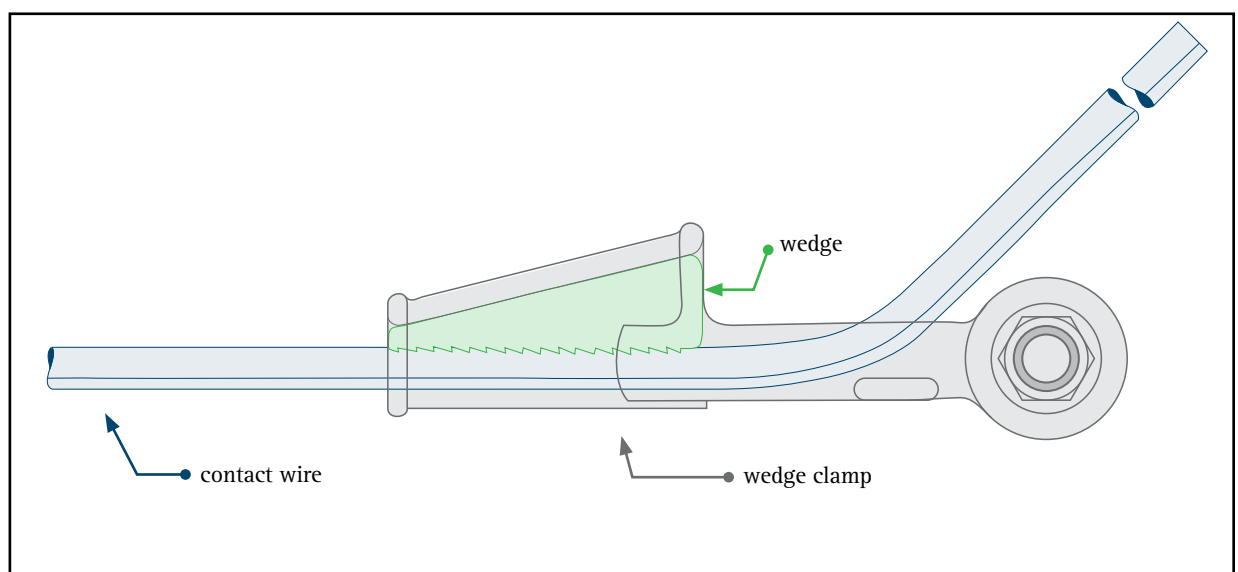
Figure 8 – Correct wedge clamp assembly.

Following the dewirement, the wedge clamp was found to be in good condition; however, the contact wire had not been installed in accordance with the approved construction drawing (Figure 8).

Appropriate installation of the wedge clamp requires that the contact wire has only a slight bend beyond the end of the wedge clamp (Figure 8). At the time of installation, the installation practice on this type of wedge clamp was to bend (loop) the contact wire around the back of the wedge clamp (Figure 9 and 10). Engineering tests, following the incident, confirmed that it is immaterial whether the contact wire is looped or not as long as the wedge has been installed properly to provide sufficient grip on the contact wire. In this instance it appears that the act of bending the contact wire prior to placing the clamp under tension has prevented it from properly engaging the wedge. The most likely failure mechanism is illustrated in Figure 13.

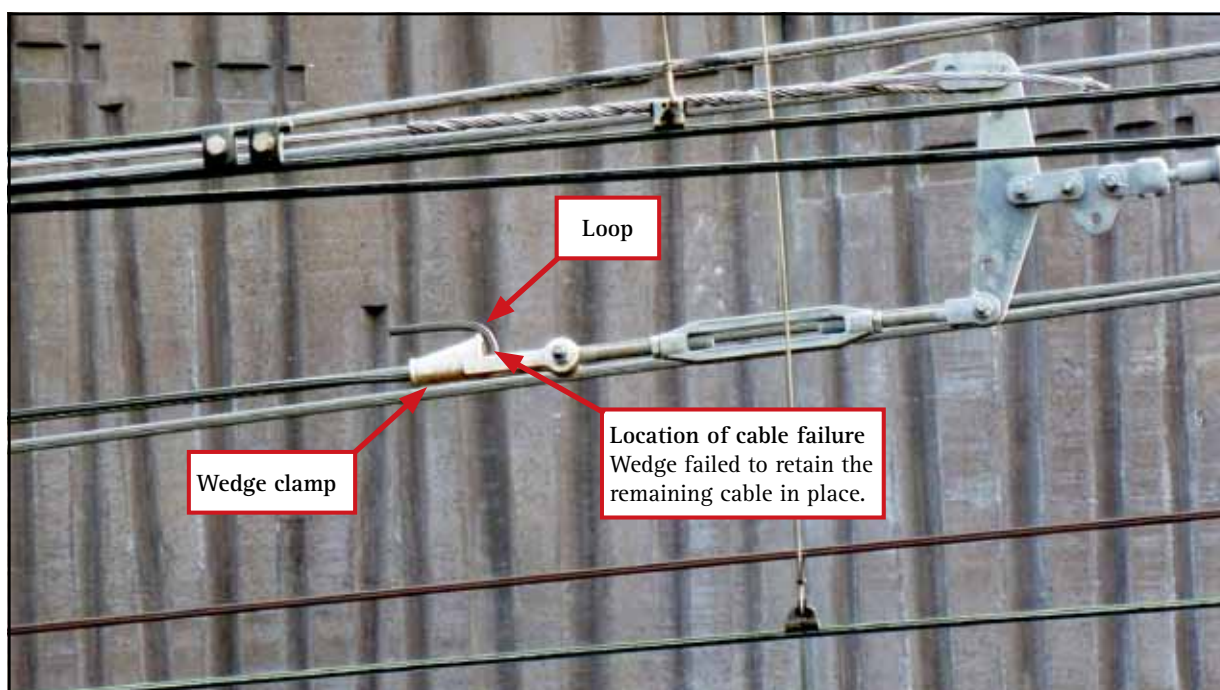
Figure 10 – Wedge clamp installation across south-east Queensland network.

It is understood that all other wedge clamps of this type across the network are installed with their contact wire end looped (Figures 9 and 10).

The incorrectly installed wedge clamp had been in service for approximately five years and was installed by Queensland Rail personnel.

The failure is the only known failure by incorrect installation among the 2000 or so clamps installed since the early 1990s.

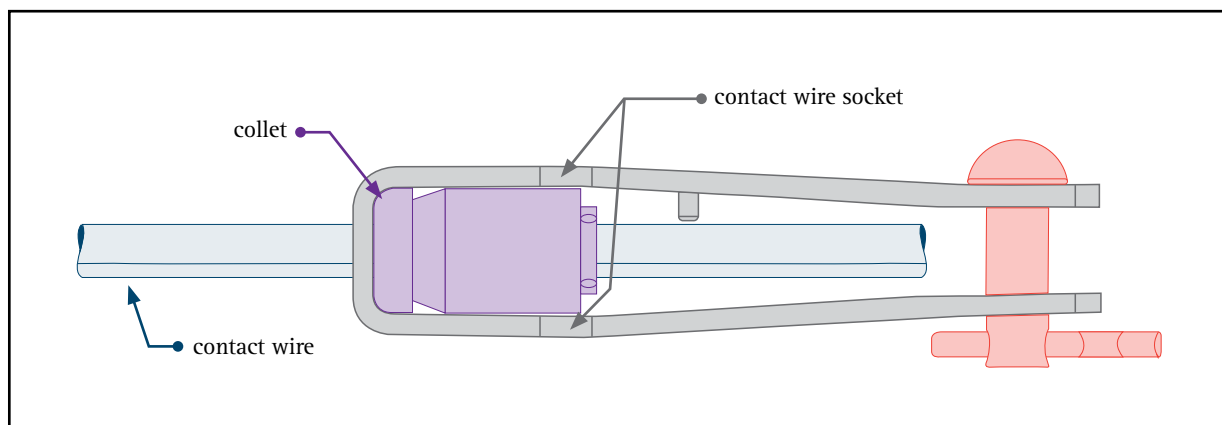
Figure 11 – New design clamps.

In 2009, Queensland Rail introduced a new design of clamp (Figure 11) which is vastly different in design from the incorrectly installed wedge clamp. The selection and introduction of the new design was made on the basis of simplicity and ease of installation. Queensland Rail has not used wedge clamps of the type which caused the failure on 28 February 2012 in new constructions since the introduction of the new type of clamp. However, the wedge type of clamp involved in 28 February 2012 incident is still used during OHLE repair and modification work.

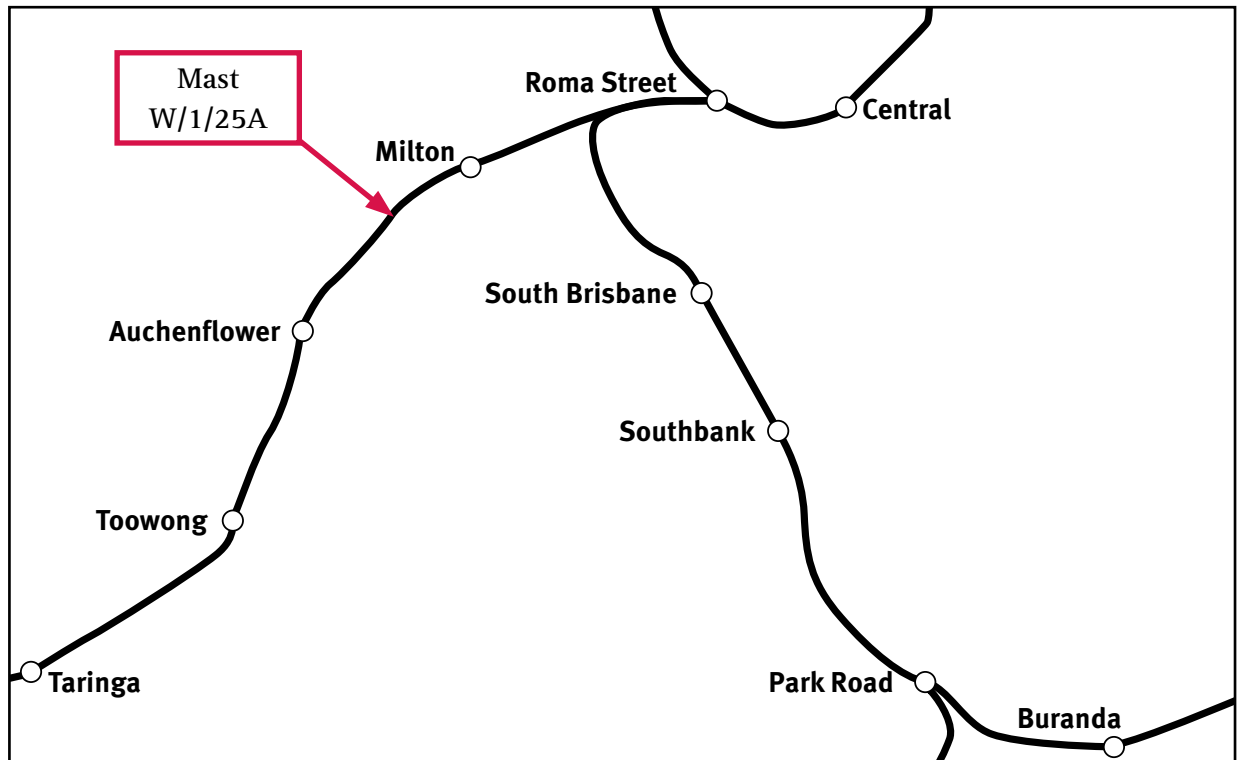
Figure 14 – 14 March 2012 Milton incident location.

The location of the damaged ceramic strut insulator on overhead line mast W/1/25A where the electrical irregularity occurred is approximately 300 metres west of Milton station on the Down Main Line between Milton and Auchenflower (Figures 14 and 15).

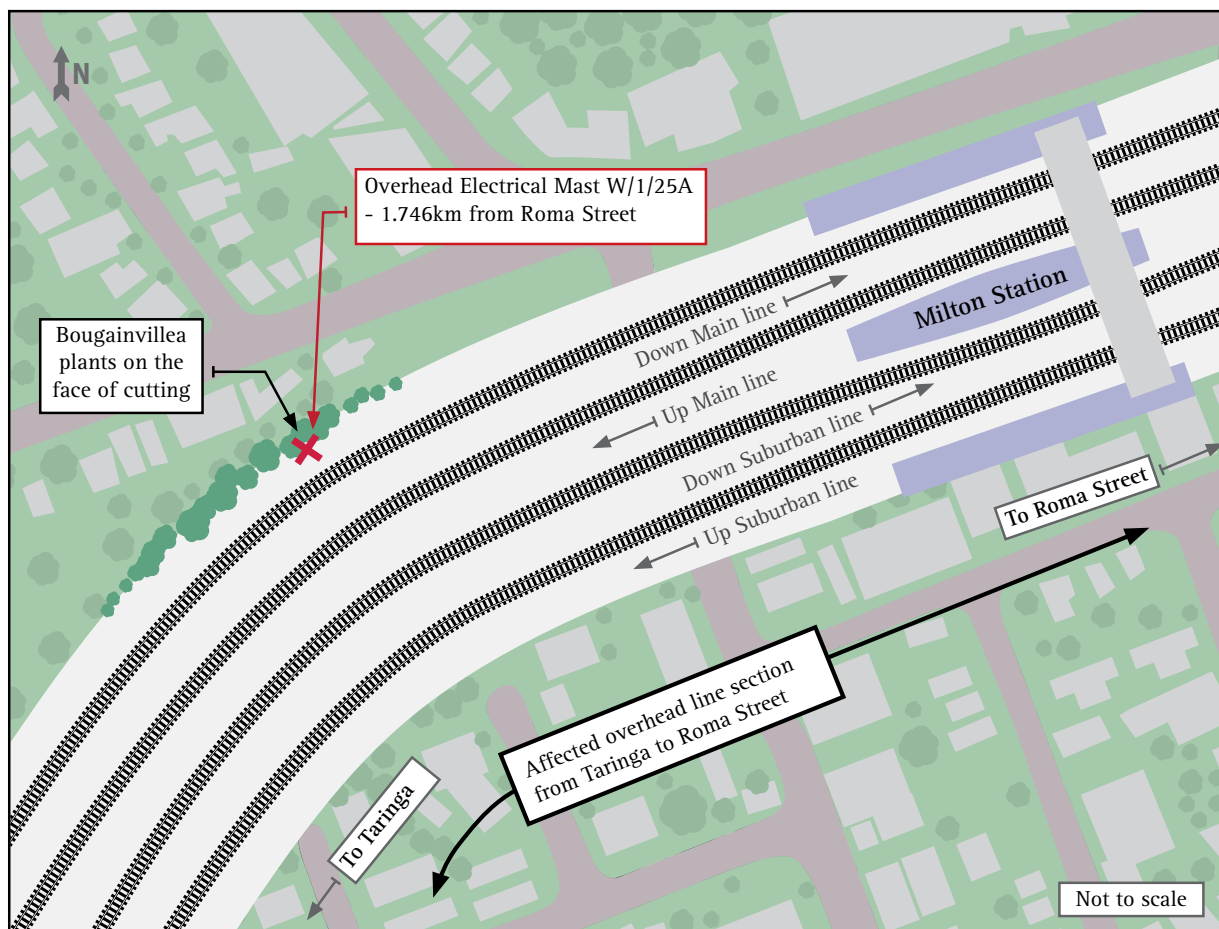
The horizontal alignment of the Down Main Line at the location of mast W/1/25A is a left hand curve (looking towards Auchenflower) of approximately 400 metre radius and with a vertical falling gradient towards Auchenflower of 1 in 79. The maximum allowable speed for electric passenger trains and freight trains is 60km/h and 50km/h, respectively.

Figure 15 – Location of incident – Milton–Auchenflower Down Main Line on the Western Corridor.

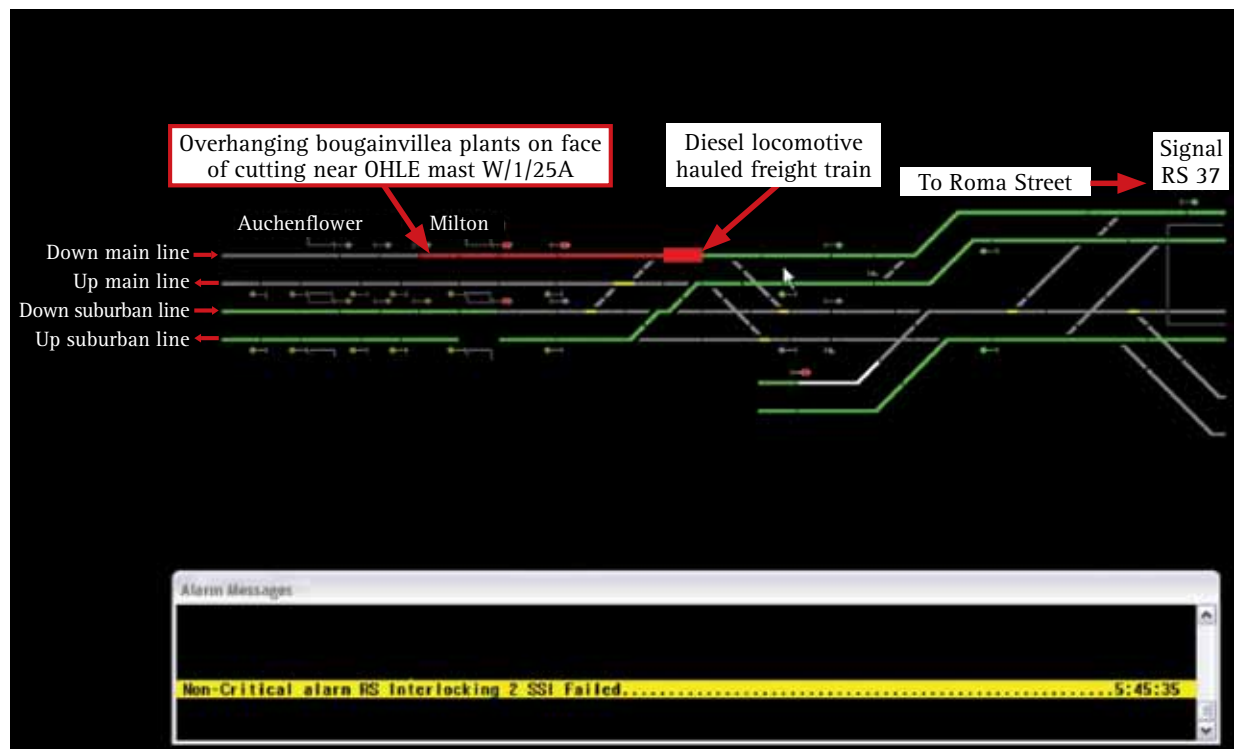
At the same time, the Train Controller received signalling fault related alarms on all tracks between Roma Street and Milton and South Brisbane (Figure 16).

Figure 16 - Train Controller's screen at the time of signalling fault alarm (unrelated screen information removed).
