9. CASE STUDIES

9 CASE STUDIES

9.1 Tugun Bypass

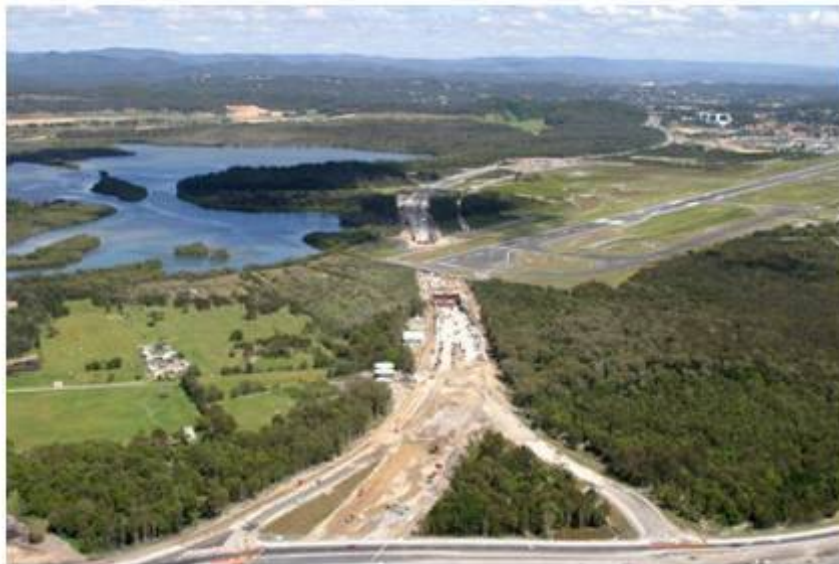
Figure 9.1.1 Tugun Bypass project under construction.

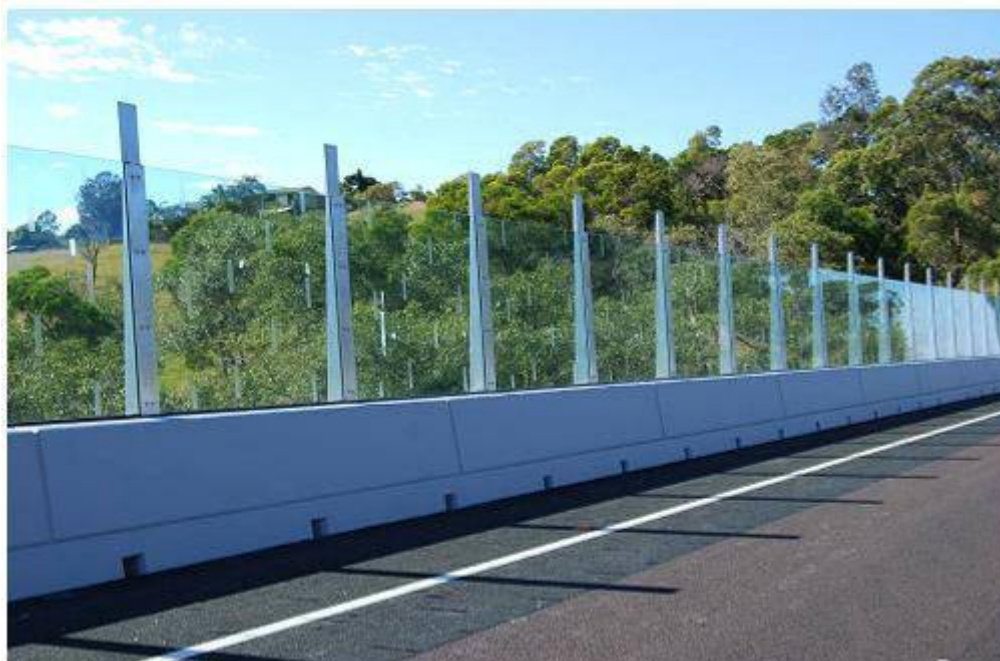
Figure 9.1.2 Transparent noise walls with pattern to prevent bird collisions (Taylor 2008).

- Monitoring was further reduced once treatment ponds and other water holding devices were either vegetated or decommissioned.
- Transparent noise walls included a rectangular pattern to minimise bird collisions (Figure 9.1.2).

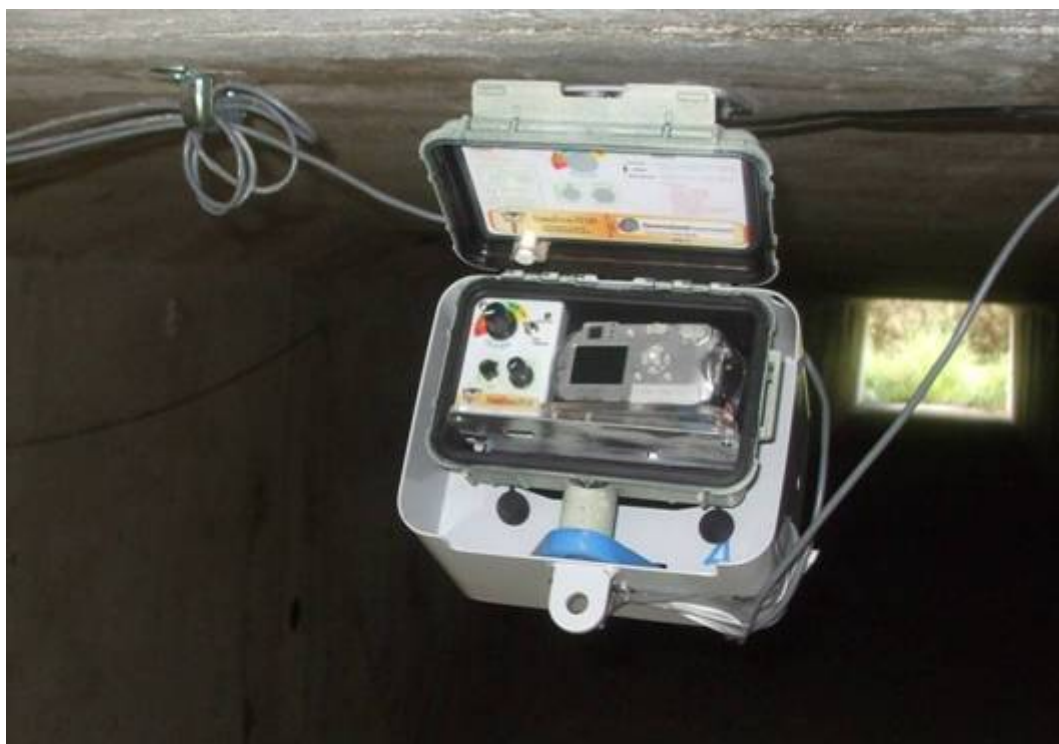
Figure 9.1.5 Infra-red still camera utilised in Boyd Street culvert

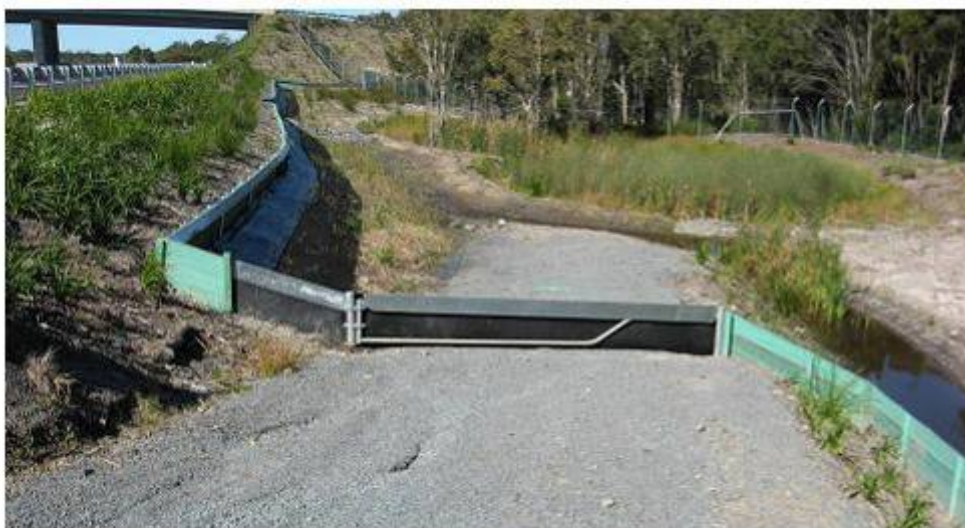
Figure 9.1.16 Specially designed frog gate across access track. Note the geofabric at the base of the frog fence.

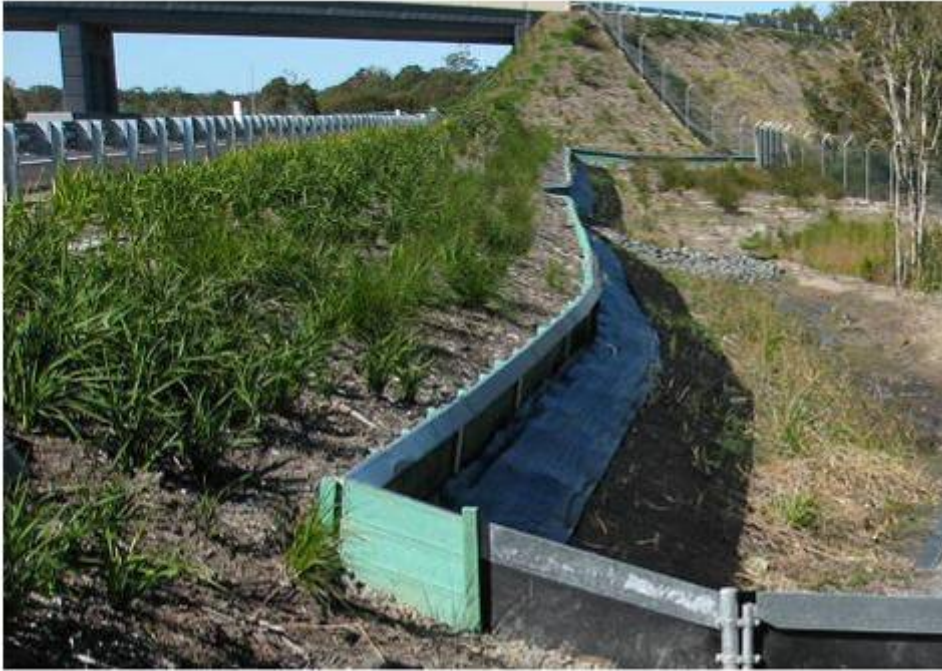
Figure 9.1.17 Backfilling behind frog fences has caused drainage problems.

- Issues have arisen due to lack of vegetation maintenance around frog fencing
- Difficult to undertake the cost-benefit analysis between price and durability for the different options (Hay 2007; Marix-Evans 2007).
- The fence was not designed as a retaining wall. However, the area behind the fence was backfilled resulting in difficulties with drainage and change in vegetation behind fence (Figure 9.1.16).
- There were issues with the fence alignment where it crossed access tracks. A special frog fence for access tracks was designed and installed to correct this issue (Figure 9.1.17).
- Fence installation led to some erosion issues below the fence line.

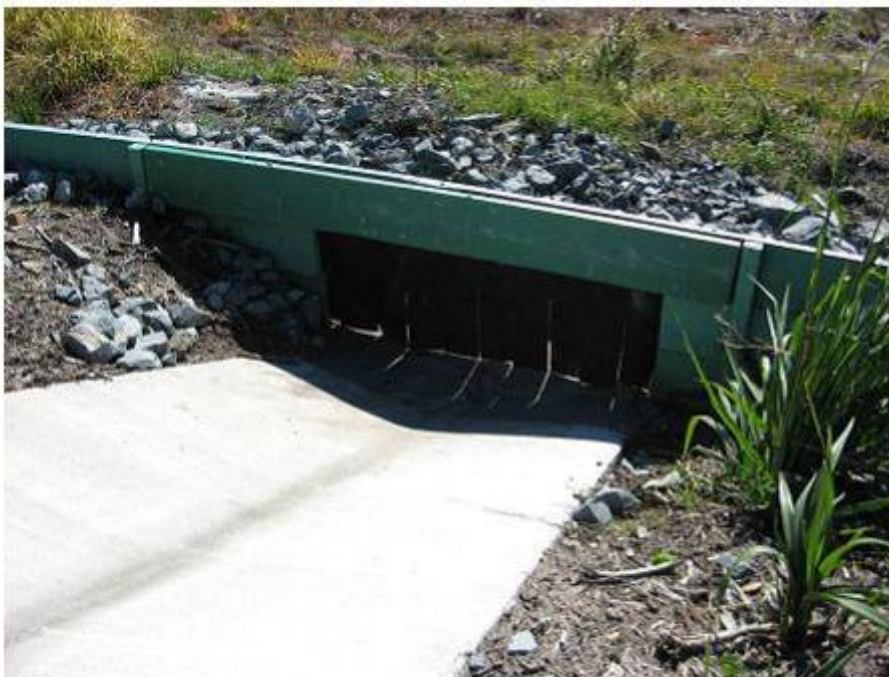
Figure 9.1.18 Concrete batter chute channelling water through the frog fence. Rubber flaps were installed to minimise frog access.

- Minor changes to the fence design were needed because batters directed concentrated water flows through the fence.
- Due to the height of the fence, it required very little vegetation adjacent to it before frogs had the potential to jump or climb over the fence.

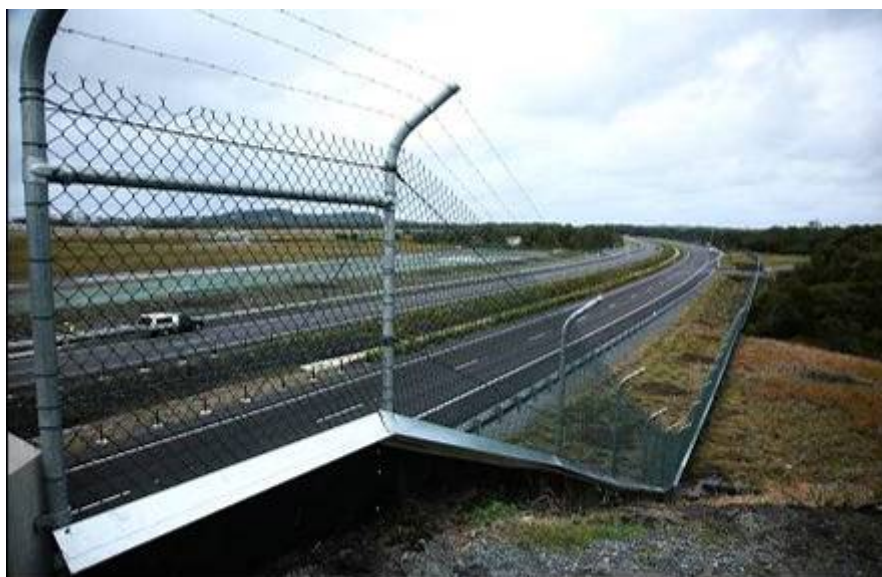
Figure 9.1.19 a) Frog fence attached to floppy top fencing.

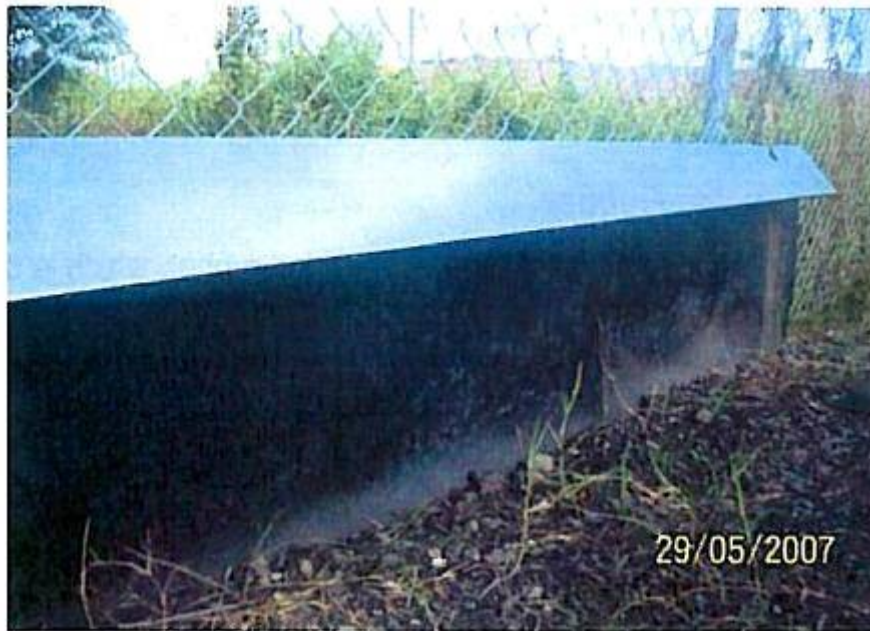
Figure 9.1.19 b) Permanent frog fence design to be attached to the existing airport security fence (PacificLink Alliance 2007).

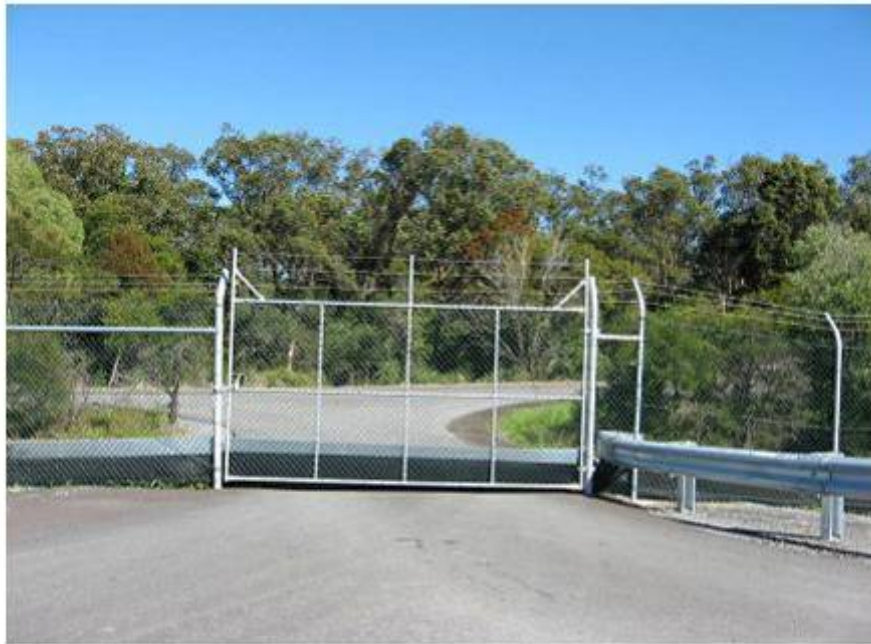
Figure 9.1.21 Security fence with frog fencing attached.

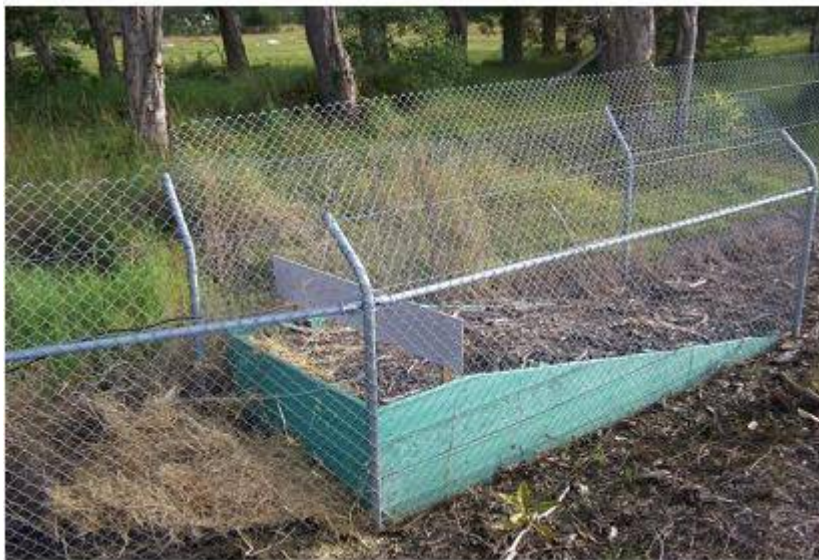
Figure 9.1.23 Retrofit fauna escape ramp.

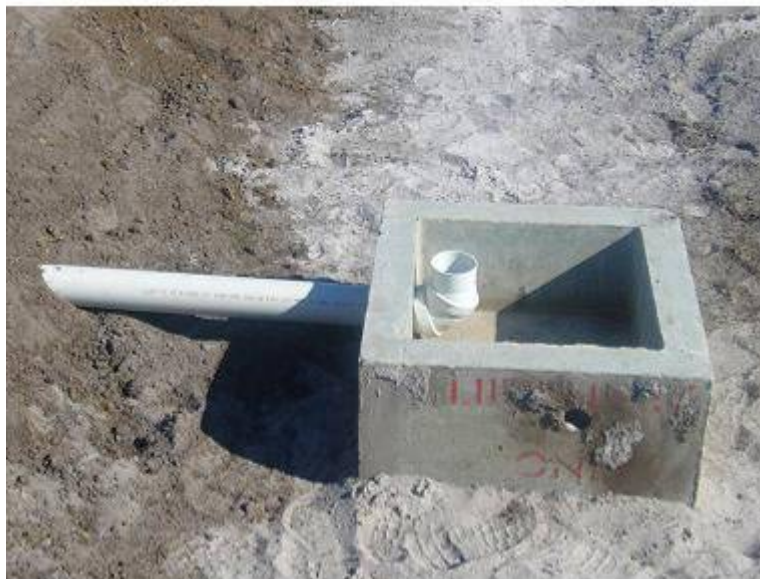
Figure 9.1.24 uPVC twister used to control water level in ponds.

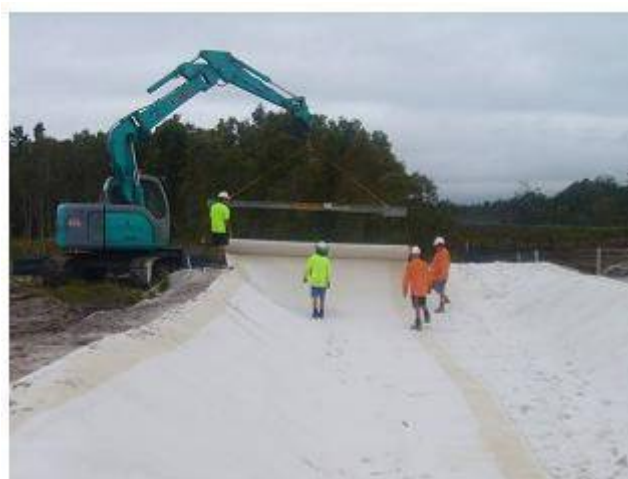
Figure 9.1.25 Frog pond construction process.

a) Laying of impermeable layer necessary to prevent the pond from drying out.

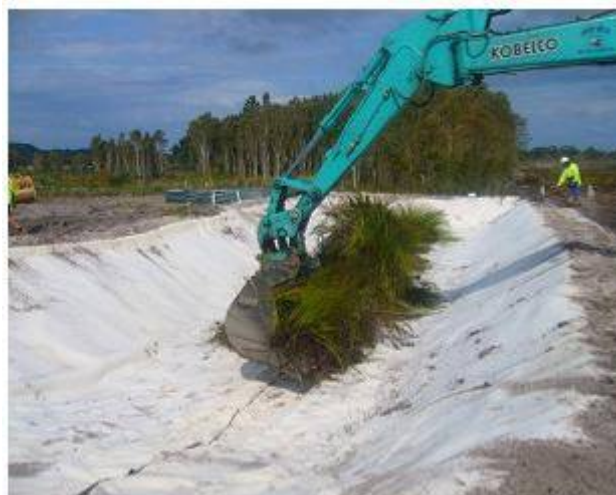
Figure 9.1.25 b) Slabbing method used to transfer wetland vegetation.

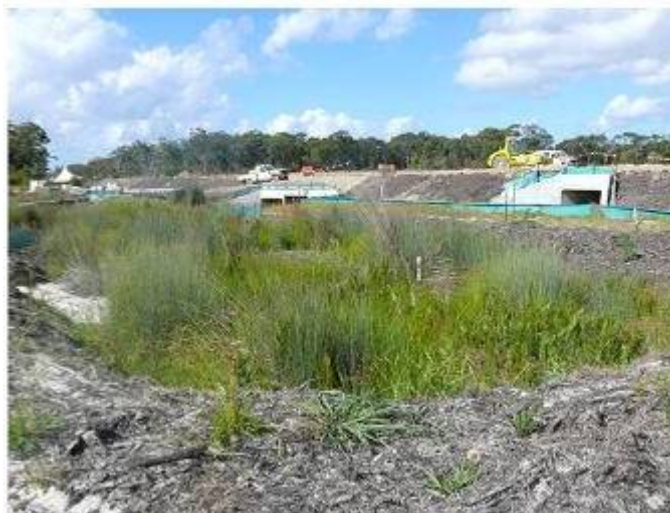
Figure 9.1.25 c) Established revegetated frog pond.

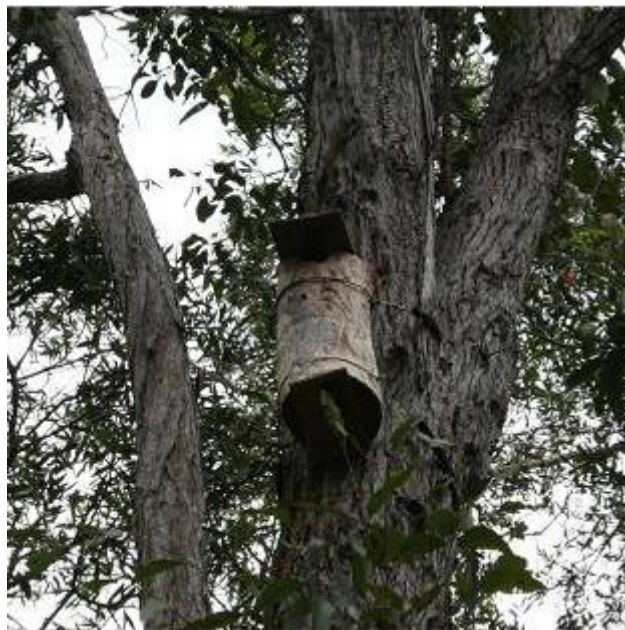
Figure 9.1.26 Nest box used to compensate for hollows lost from Tugun Bypass construction (Environment and Heritage presentation 2007).

- Nest boxes were installed away from human pathways and approximately 4-8 metres above ground by a flexible metal strap to allow for tree growth (PacificLink Alliance 2007; PacificLink Alliance 2006c).
- Replacement hollow logs were sourced from other construction sites to provide a more natural habitat.

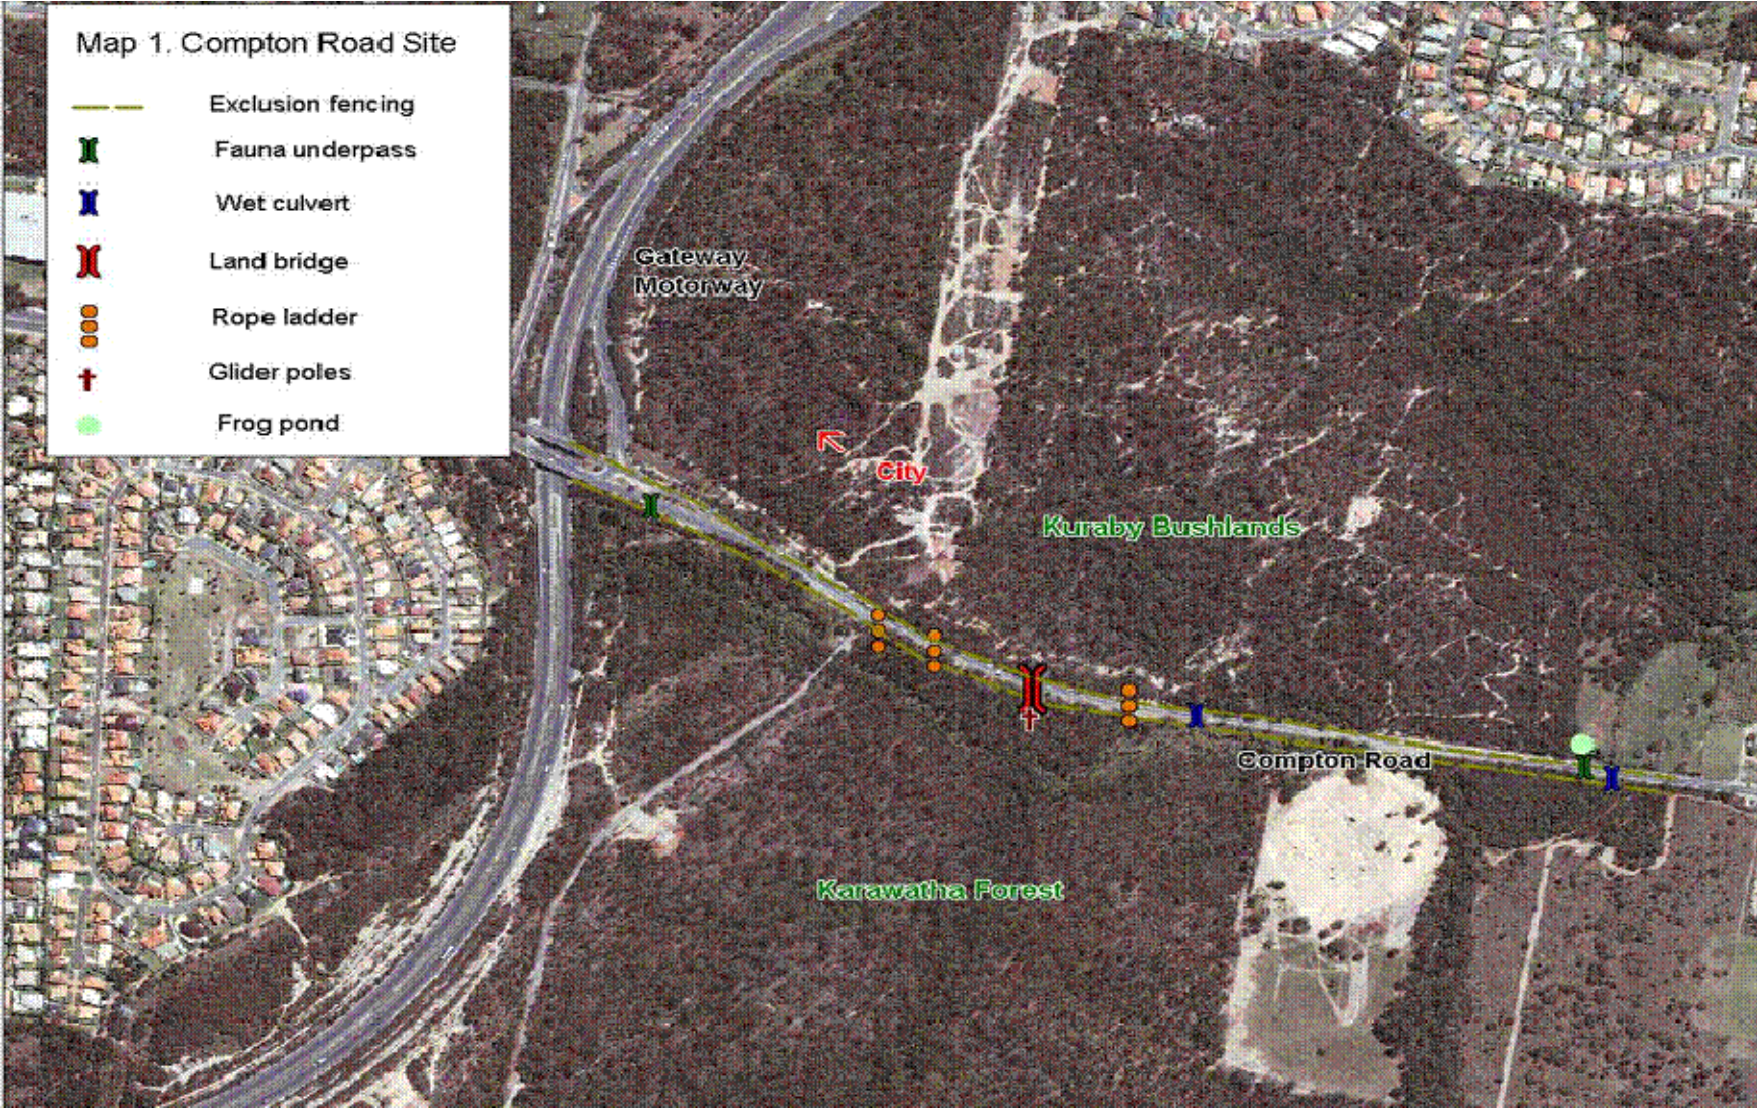
Figure 9.2.1 Location of Compton Road and fauna mitigation measures (Veage and Jones 2007).

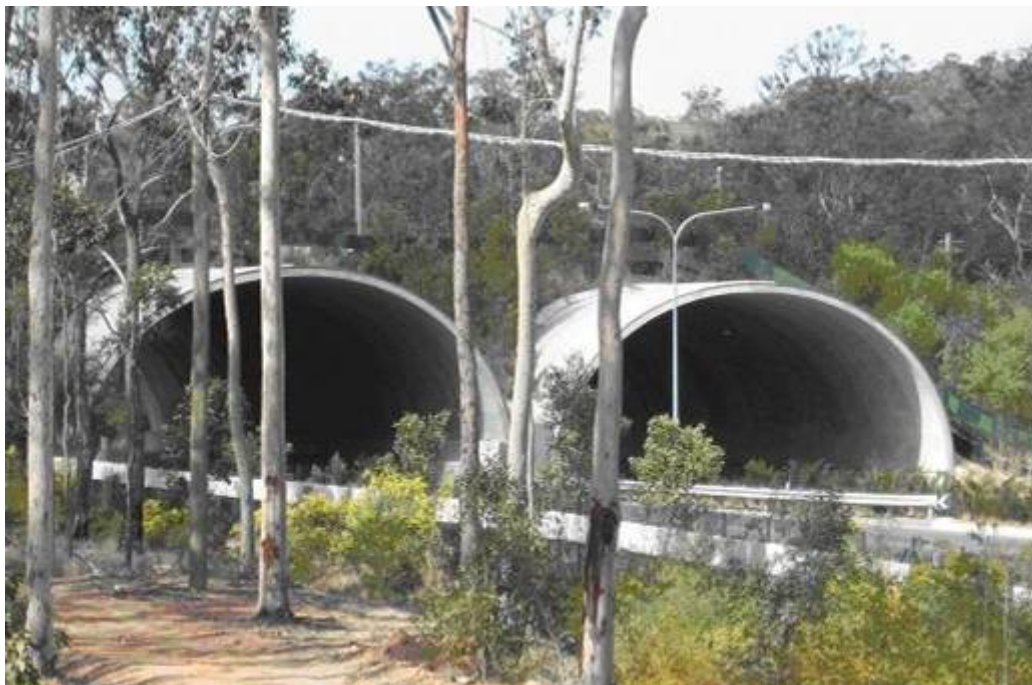
Figure 9.2.2 Land bridge at Compton Road (Robinson-Wolrath 2008).

- Figures 9.2.2 and 9.2.3.
- Arched and hourglass.
- Dimensions:
 - Length: 70 metres, base width: 20 metres, mid-width: 10 metres.
 - Height is eight metres above the road.
 - Each vehicle tunnel is 5.4 metres high.
 - Slope of the batters on either side is 1:3.
- Roadside fauna exclusion fence is continuous along both sides of the road for the entire length of the upgraded road and keys into the land bridge.
- The land bridge vegetation consists of local shrub, tree and grass species. However, vegetation at either end of land bridge was not replanted. This has caused a gap between the land bridge and forest vegetation until natural regrowth establishes.
- Vegetation growth on the land bridge was aided by a drip irrigation system and between two and three metres of mulch during the early stages of plant establishment.

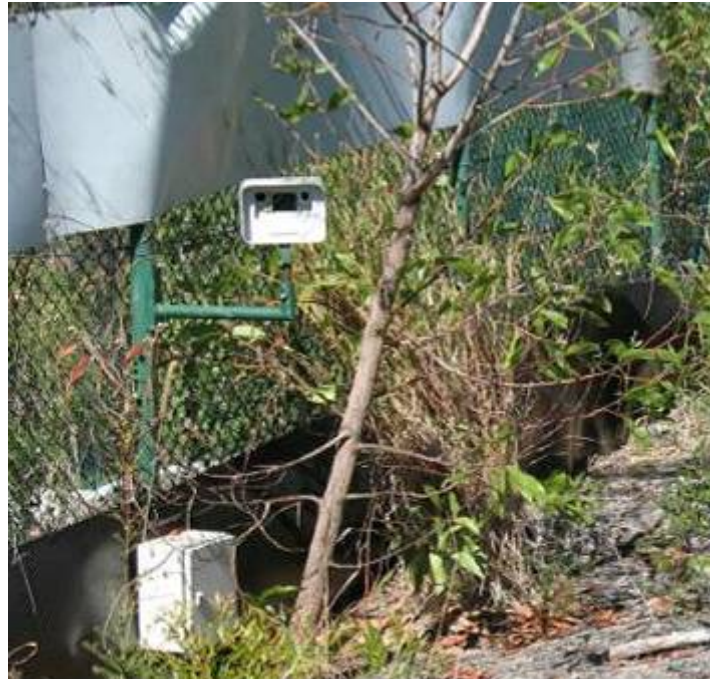
**Figure 9.2.4 a) Faunatech Digicam used to monitor use of land bridge (Veage and Jones 2007).
b) Active infra-red beam sensors (Veage and Jones 2007).**

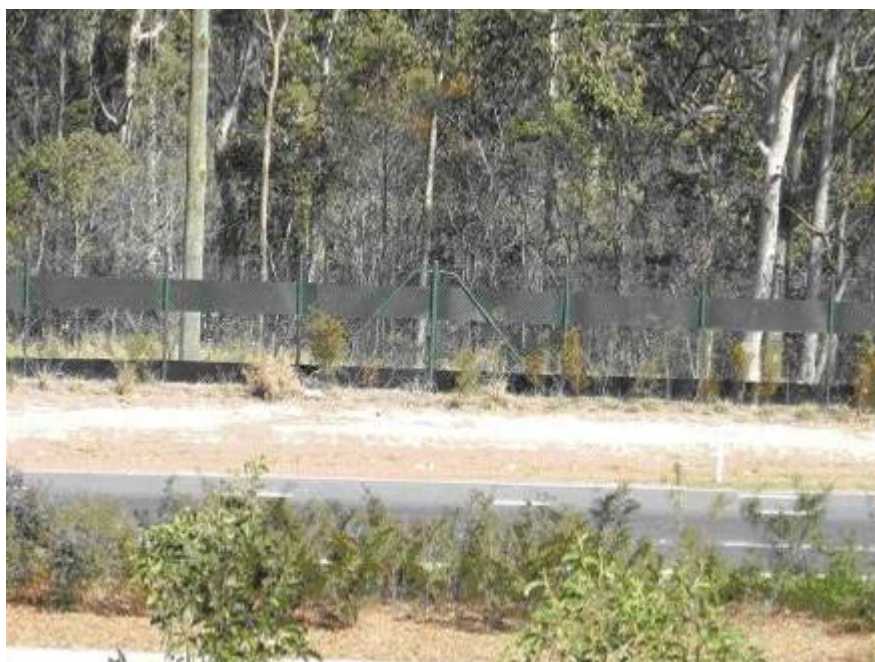
Figure 9.2.5 Fauna exclusion fencing at Compton Road (Robinson-Wolrath 2008).

- Aim of the structure is to guide fauna towards safe fauna crossing structures.
- The fauna exclusion fence is continuous along both sides of the road for the length of the upgraded road.
- Dimensions:
 - 2.48 metres high.
 - Extends five centimetres into the ground (Figure 9.2.5).
- The fence is constructed of rubberised metal mesh.
- A UV stabilised root barrier 3 mm thick and 480 mm high runs along the bottom of the fence and extends 300 mm into the ground. The sheet is attached to the forest side of the fence.
- A rolled metal sheet, 590 mm wide and 1.38 metres above the ground, is attached on the forest side of the fence to discourage climbing animals.
- Timber escape poles are located every 50 metres on the roadside of the fence.

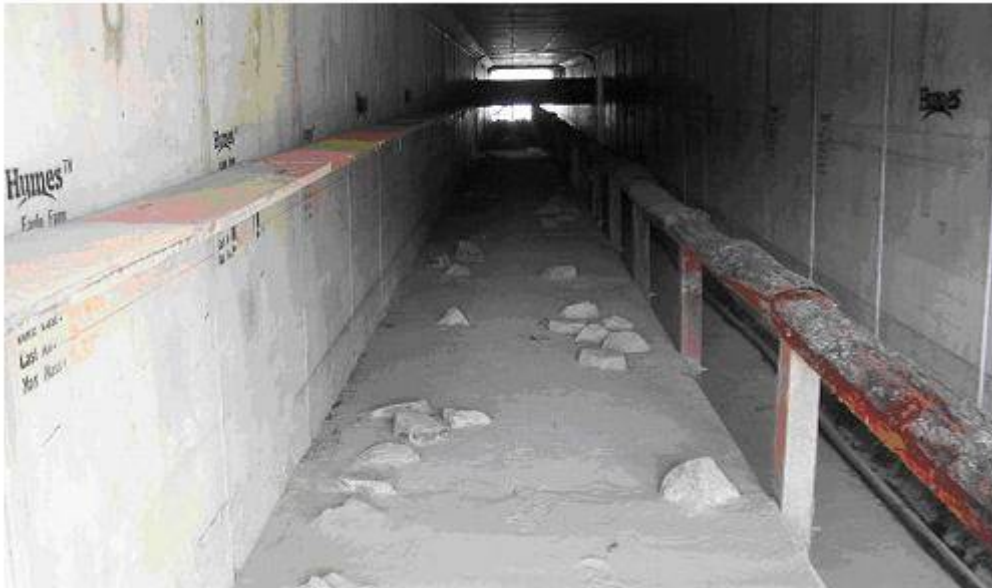
Figure 9.2.6 An underpass at Compton Road. Note the raised cement level with rock ‘furniture’, wooden shelf and log railing (Bond and Jones 2006).

- Two fauna-specific concrete culverts were installed (Figures 9.2.6 and 9.2.7).
- Dimensions:
 - 2.4 metres high;
 - 2.5 metres wide;
 - 48 metres long.
- Contains three levels:
 - A lower cement level (0.9 metres wide) for water flow.
 - A raised cement level with rocks, leaf litter, sand and gravel as furniture:
 - This level is 1.6 metres wide and 400 mm above the ground, leaving a height of two metres from this level.
 - Although rocks were embedded into the concrete, natural processes are required to deposit sand, gravel and leaf litter.
 - Two shelves are provided along the entire length of the underpass to provide dry passage and safety from predators:

- A small wooden shelf (250 mm wide) attached to the wall of the underpass aims to facilitate the passage of smaller species without requiring them to move along the relatively open area of the underpass floor; and
- A raised half-log railing one metre from the bottom of the culvert. Entrance poles on the end of this railing are installed.
- The substratum is cement which allows for water flow if required.
- One of the culverts has a gully in the median that acts as a skylight and is connected to an artificial pond.

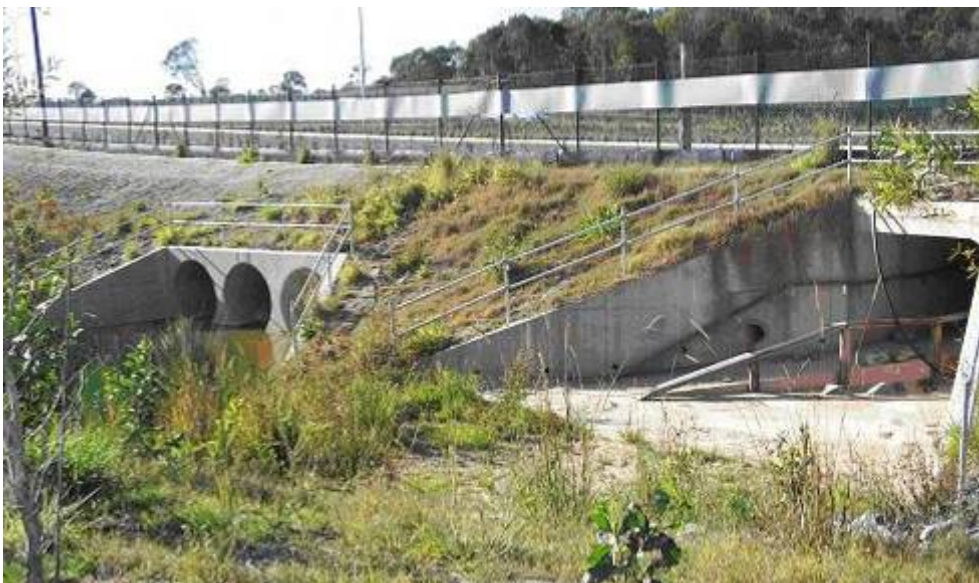
Figure 9.2.7 Kuraby Bushland entrance to an underpass and the wet culverts opening into an artificial pond. The fauna exclusion fence is also visible above the culverts (Bond and Jones 2006).

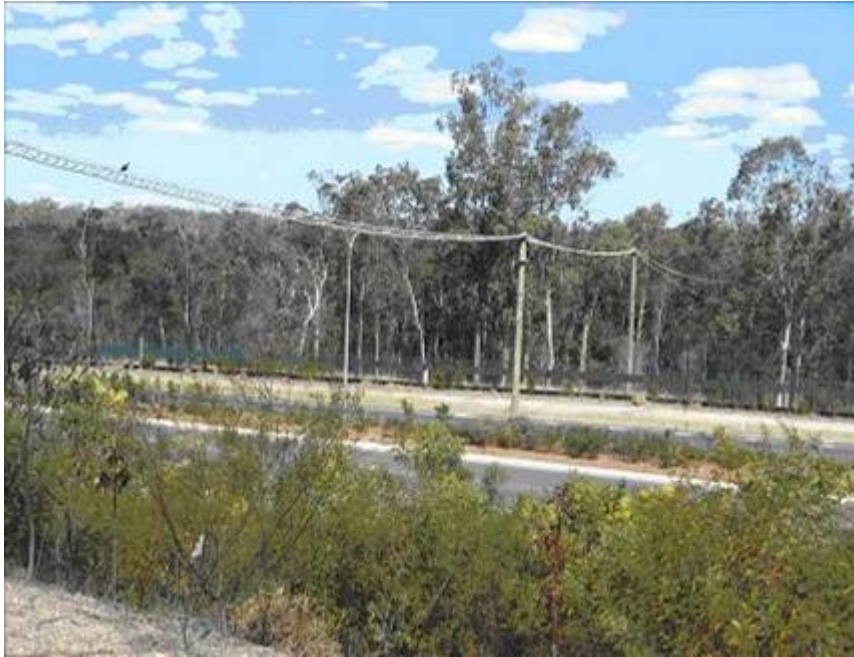
Figure 9.2.10 Canopy bridge used by arboreal species to the road (Scott 2007).

- Three rope ladders were installed, each with a centre pole in the median strip (Brisbane City Council 2005).
- The rope ladders are constructed with durable sailing rope and resemble a ladder with three vertical supports.
- The rope bridges are linked to the adjoining canopy via several ropes leading from the top of the poles adjacent to the forest.

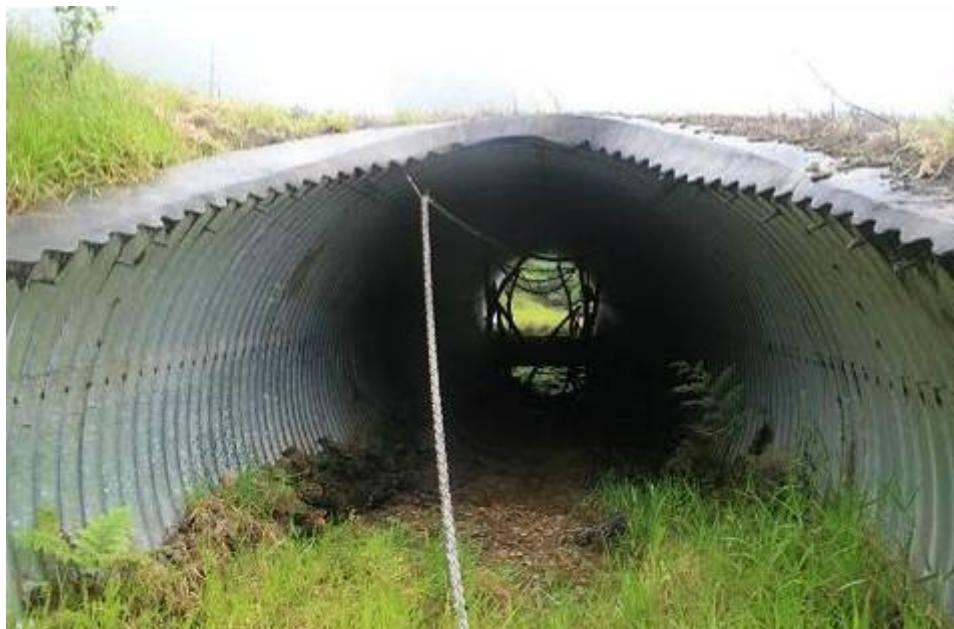
Figure 9.3.1 Fauna underpass at East Evelyn Range (Scott 2008).

- Three fauna underpasses were installed (Figure 9.3.1).
- Underpasses were galvanised steel arches with a wide concrete base (Gibson 2001).
- Dimensions:

- Ground cover consisted of logs, rocks, leaf litter and soil to replicate a natural environment (Gibson 2001).
- Thick trawler ropes were hung from the roof of culverts and extended to neighbouring trees for use by obligate arboreal species (for example, tree-kangaroos) (Gibson 2001) (Figures 9.3.1 and 9.3.2).

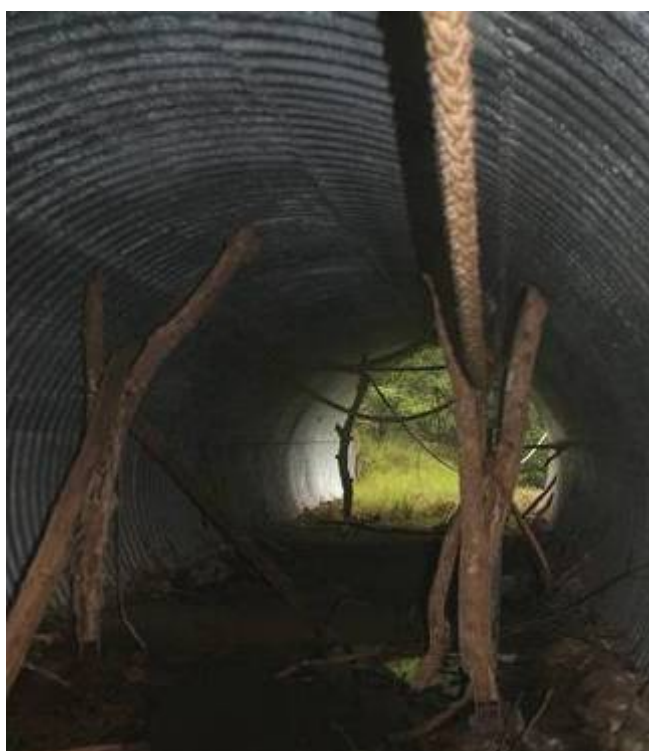
Figure 9.3.2 Fauna furniture in underpass (Scott 2008).

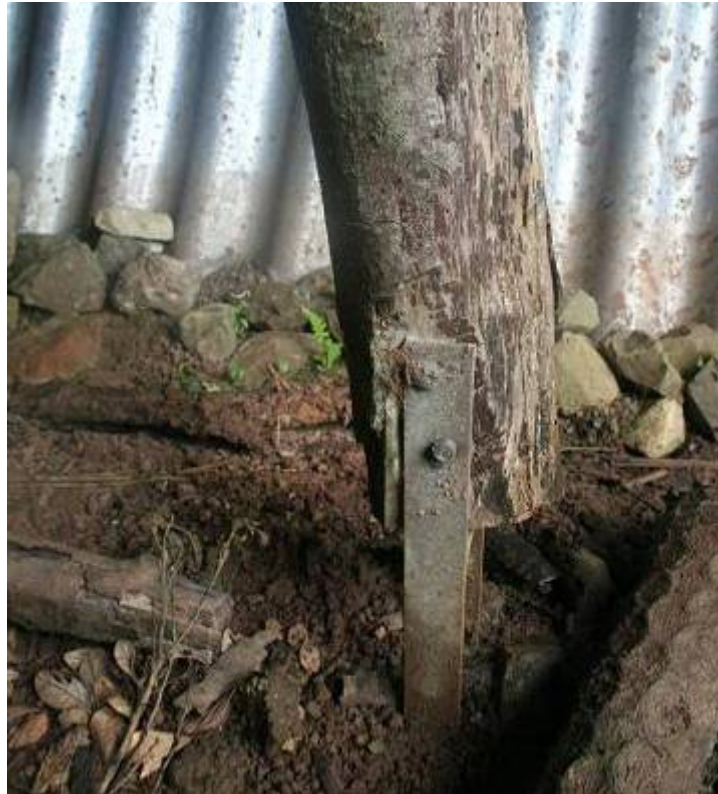
Figure 9.3.3. Footings for underpass furniture (Scott 2008).

- Footings for underpass furniture allow logs to be raised off the underpass floor (Figure 9.3.3). This prevents rotting and extends log life.
- Escape poles were installed to accommodate arboreal species (Goosem *et al.* 2001; Goosem 2004).
- Infra-red monitoring cameras were placed in cages to reduce the likelihood of theft (Figure 9.3.4).

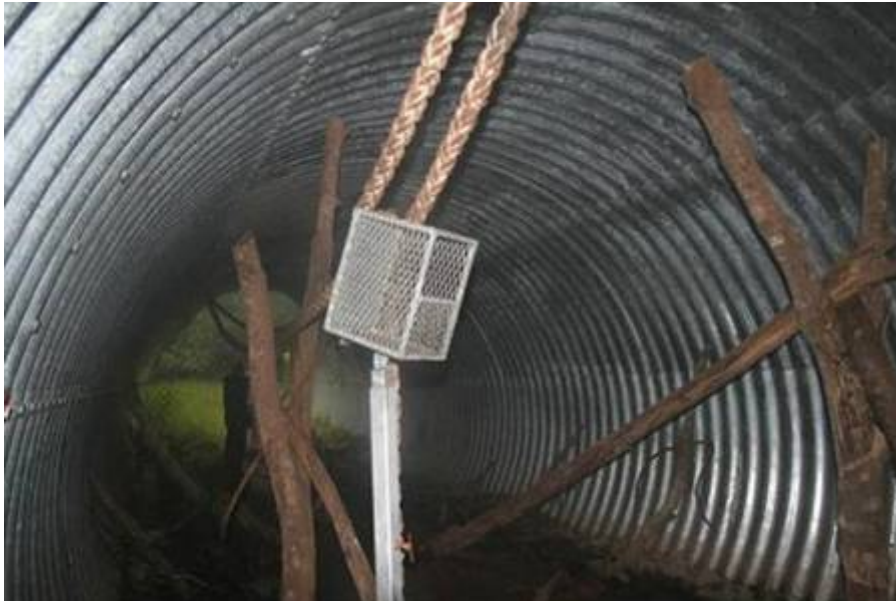
Figure 9.3.4 Infra-red monitoring cameras were caged to prevent theft (Scott 2008).

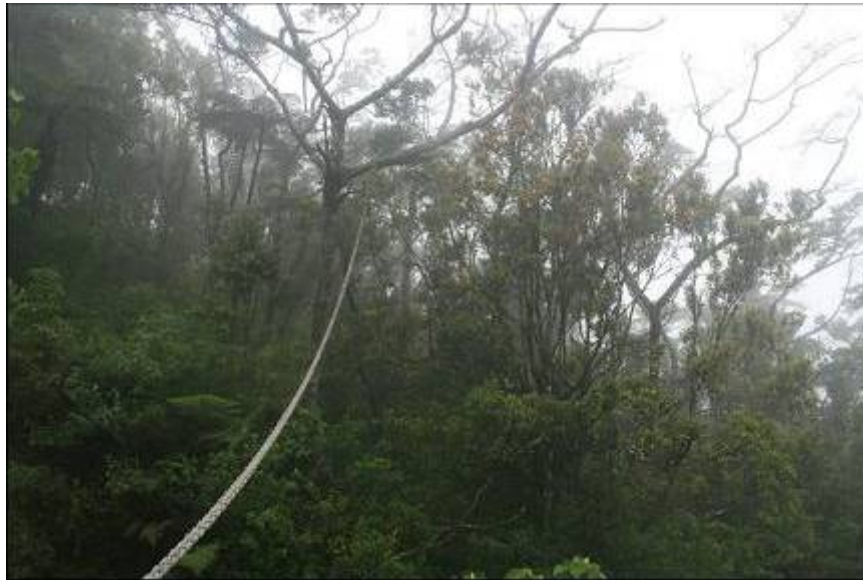
Figure 9.3.5 Trawler rope connecting the surrounding vegetation to hooks inside the underpass (Scott 2008).

- Trawler rope connected to hooks inside the underpass extended into vegetative corridor (Figure 9.3.5).
- A funnel shape corridor measuring nine metres wide at the entrances to the underpasses and 50 metres wide near rainforest remnants was revegetated (Goosem *et al.* 2005).
- Monitoring of corridor did not occur.

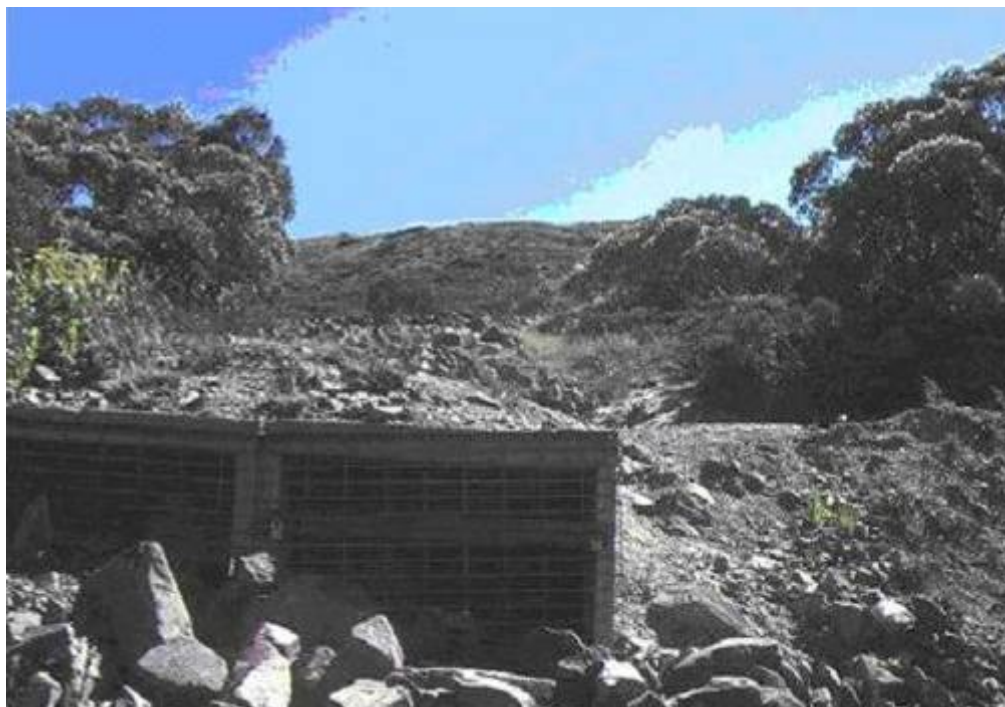
Figure 9.4.3 Entrance to the rock underpass (ABC 2009).

- A funnel shaped corridor of basalt rocks was constructed on the disturbed eastern slope between the largest remaining patches of habitat (Figures 9.4.2 - 9.4.4).
- Rocks were obtained from building excavations.
- Two culverts were installed and filled entirely with rock. Rocks used to fill the culverts were greater than 300 mm on their longest axis.
- Box culverts measured 900 mm x 1.2 metres.
